Residential Fire Risk Assessment

Regulatory Reform (Fire Safety) Order 2005

Building	Rye Hill Park 34-120
Area	Peckham
Postcode	SE15 3JU
Unique Property Reference Number	PHAU05120501
Estate / Patch	Rye Hill Estate,
Date Assessed	17/11/2021
Completed by	Earl Johnson
Status	Complete
Risk Rating	High Moderate
Next Assessment Due Date	November 2022

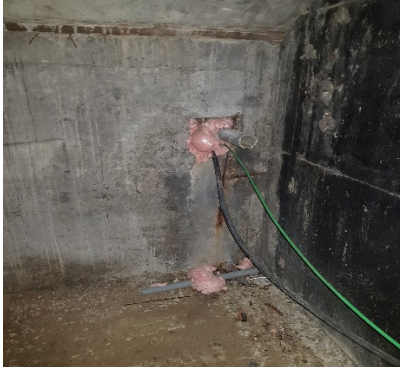
<p>Visible compartmentation issue</p>

Issue	Firestopping issues.
Proposed Action	There are numerous areas within the lower ground floor area, within the electrical intake cupboard and within the access lobby area leading to the mains water booster pump room and the water tank room. Non-flammable expanding foam has been used to fill holes, this type of foam is only suitable for certain size gaps/holes. It is also noted that similar material has been applied to the electrical riser area. Due to the number of areas noted a firestopping survey is required to be carried out and areas identified within the survey to be suitably firestopped. The firestopping survey is also required to include the phone line riser also located within the lift lobby areas on all floors. The firestopping survey should also look into the 10th floor ceiling area, on the external balcony areas, to both sides of the building (area above the refuse hopper and old drying cabinets) where trunking which runs from one wall to another which leads into flats. It is not known what the trunking is used for, what the construction of the cover panel is and if the trunking actually runs into the dwellings themselves and have suitable firestopping in place. This area should be investigated and any issues highlighted within the investigation addressed accordingly. Firestopping survey document to be provided to the Fire Safety Team, for reference purposes.

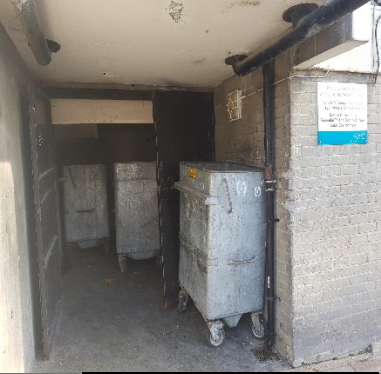
<p>Waste management area</p>

Issue	Recycling paladins stored up against the building are required to be removed.
Proposed Action	Recycling paladins are required to be stored away from the building (at least 1.8m away from building), preferable in a designated site away from the building.
Priority	Low

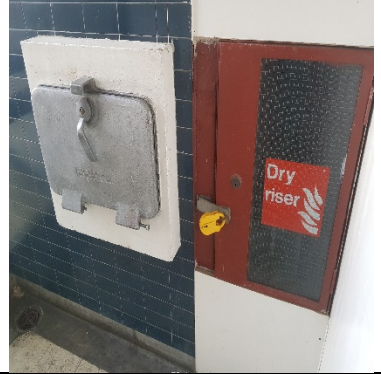
It is noted that the premises has a refuse hopper system, with the hopper located on an external balcony via a FD60S SC door. The following refuse hoppers are disrepair and are required to be repaired: 4th, 7th and 9th floor.

<p>4th floor damaged refuse hopper and dry riser outlet</p>

Issue	Refuse hoppers are required to be repaired.
Proposed Action	The following refuse hoppers are disrepair and are required to be repaired: 2nd, 4th, 7th and 9th floor, x4 in total.
Priority	Low

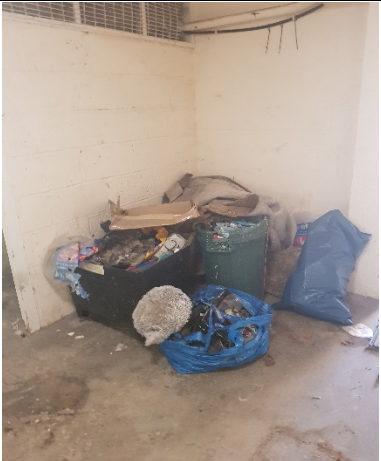
<p>Rubbish within lower ground floor residents storage cupboard area</p>
