Southwark Council

Ledbury Estate

Structural Robustness Assessment
for Large Panel System Tower
Blocks with Piped Gas

Issue 2 | 30 August 2017

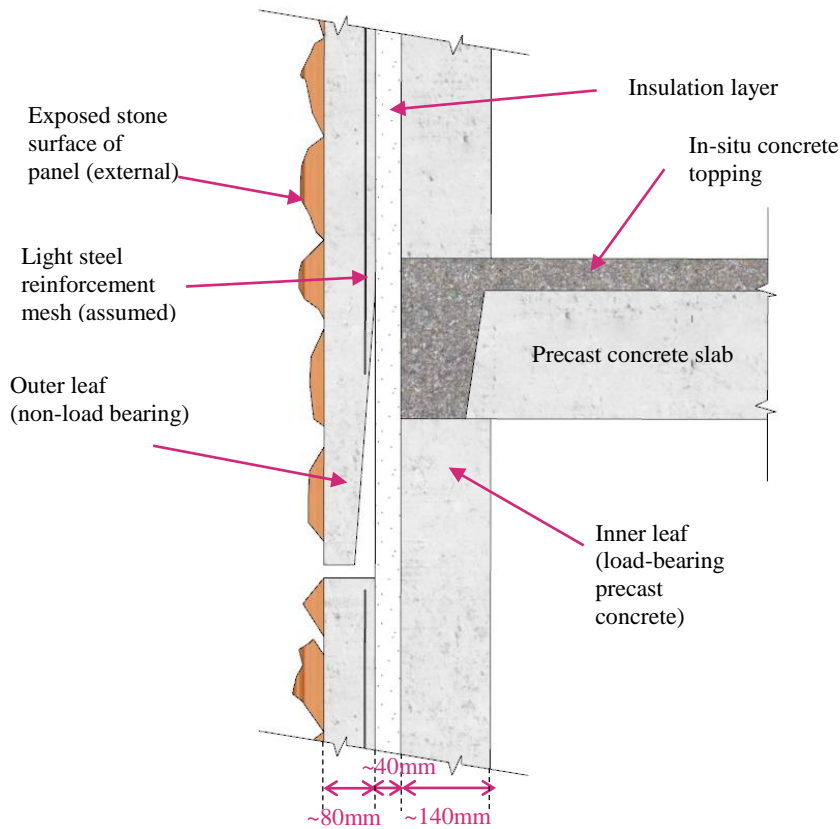
A sketch of the cross-section of a flank wall panel, based on the investigation findings, can be seen in Figure 5. The panels consist of two concrete leaves separated by an insulation layer. The inner leaf of the panel bears all of the vertical load provided by the slabs (i.e. the weight of the building goes through the inner leaf). The outer leaf simply provides the weather proofing skin. As a result, our investigations focussed on the inner leaf.

Figure 5 Cross-section of the flank wall panel

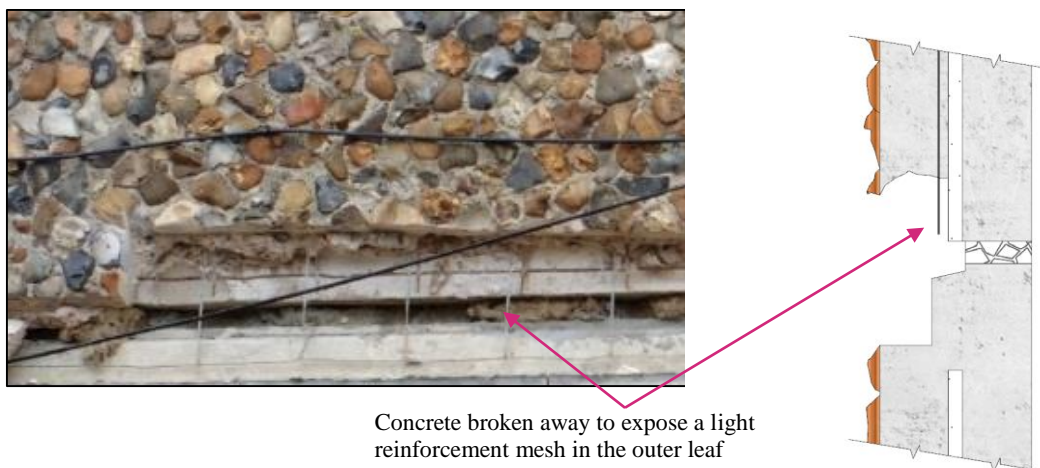
Figure 6 Light reinforcement mesh in the outer leaf of a non-structural wall panel. Photograph looking straight at the panel (LHS). Sketch showing a section through the wall panel, demonstrating the extent to which the concrete was broken away (RHS)

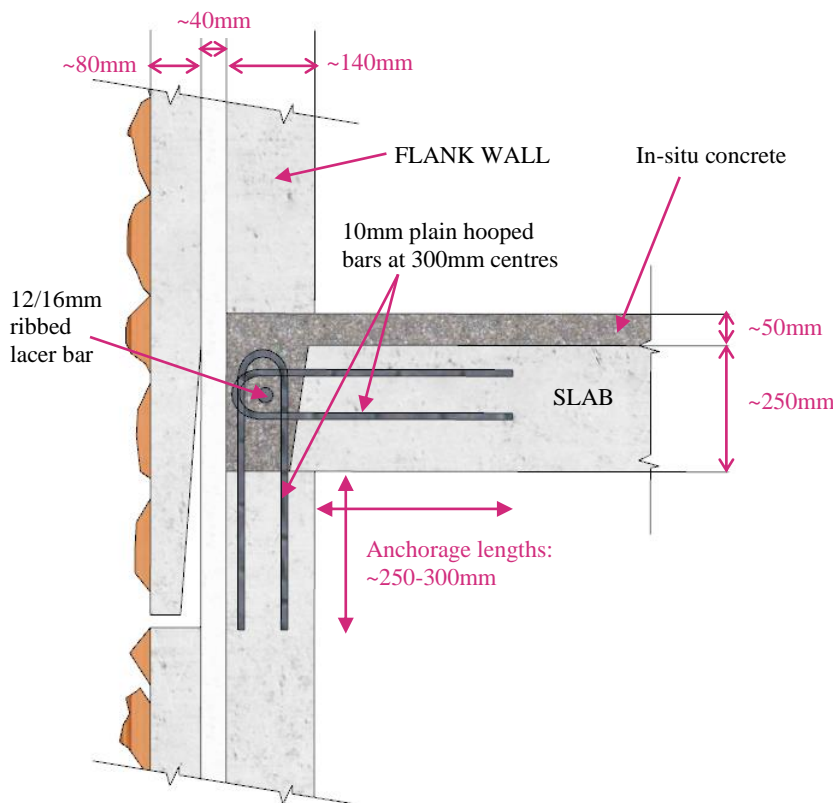
Interlocking reinforcement between the top of the flank wall panels and the floor slabs was found; located at 300mm centres. A sketch of this detail (based on the investigation findings) can be seen in Figure 7. Three fixings were exposed; two at location 3 and one at location 10 (seen in Figure 4).

10mm diameter plain hooped bars extend from the top of each flank wall panel and from each slab. These hooped bars are linked by a horizontal ribbed ‘lacer’ bar. These lacer bars were observed to be 12mm in diameter in Skenfrith House (location 10) and 16mm in diameter in Bromyard House (location 3). At location 3, two bars were discovered indicating a position of a lap. The voids between the precast panels are filled with in-situ concrete.

Plain bars circa 1968 suggest ‘R’ type bars with a characteristic yield strength of ~250MPa. Ribbed bars suggest ‘T’ type bars with which typically had a characteristic yield strength of ~410-450MPa.

Figure 7 Flank wall panel to floor slab fixing detail

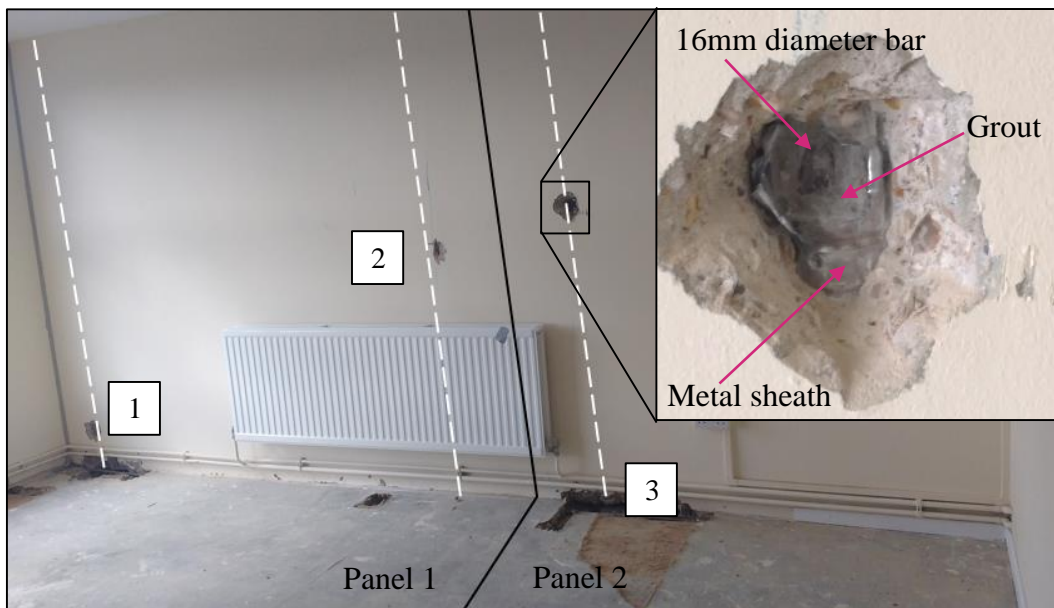
Each flank wall panel is connected to the flank wall directly above and below by two vertical 16mm diameter ribbed steel reinforcement bars at either side of each panel. These bars are contained within 45mm diameter metal sheaths which were fully grouted at the exposed locations. The non-destructive scanning tools detected that the sheaths extend the full height of the panel and local break-outs revealed that the vertical steel bars extend into the in-situ concrete joint (between the wall and slab). The extent to which the base of the fixings were exposed at the base of the wall panels can be seen in Figure 11. Sketches of this fixing detail (based on the investigation findings) can be seen in Figure 9 and Figure 10. A photograph showing locations 1, 2 and 3 (Figure 4) can be seen in Figure 8.

Figure 8 The locations of the vertical bars in the flank wall panels (located by electromagnetic scanner), are shown in white. The close-up photo shows an exposed metal sheath and bar at mid-height

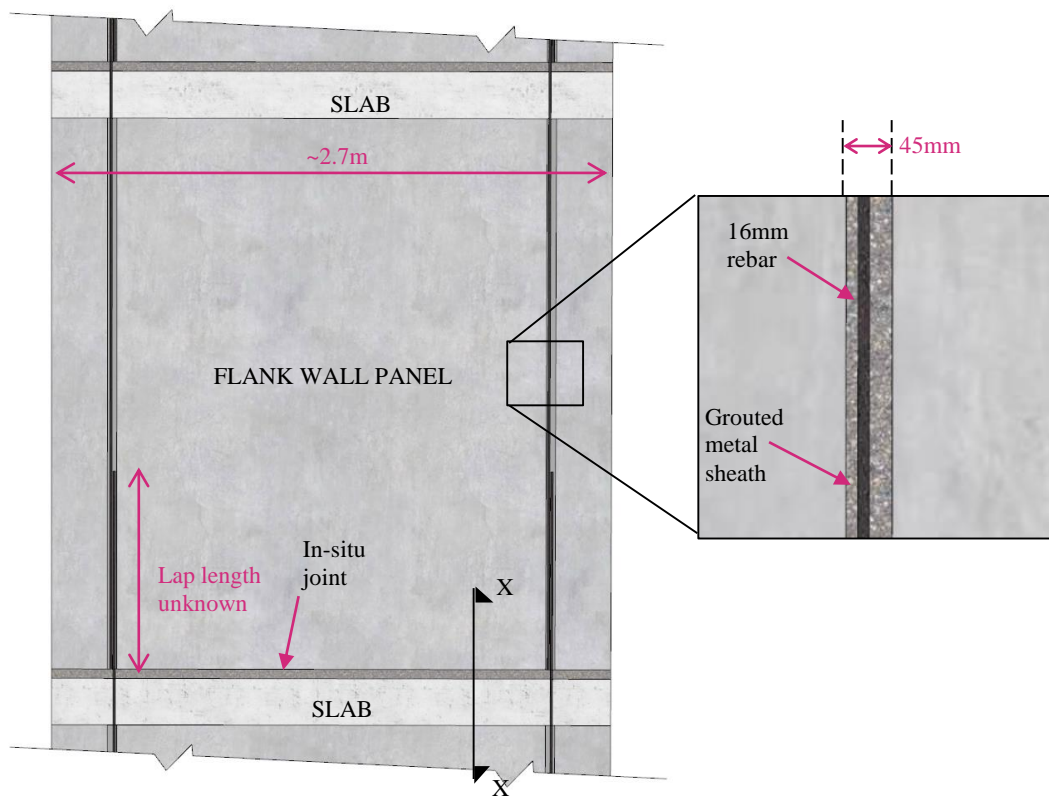
The location of each vertical joint was initially located using the non-destructive scanning tools and four locations were subsequently intrusively investigated; locations 1, 2, 3 and 9, as seen in Figure 4. At location 1, the base of the joint was exposed and two steel bars were observed, this is assumed to be the lapping of the vertical bars, one bar ends just below the bottom of the sheath and one bar extends into the in-situ joint. At location 2, the sheath and bar were exposed at mid-height – a single bar was found. At location 3, both the base and top of the joint was exposed. In both instances a single bar extending into the in-situ joint was observed. The bar and sheath was also exposed at mid-height at this location; again revealing a single bar. At location 9 the base of the joint was exposed and a lapped detail similar to that at location 1 was observed.

Figure 9 Flank wall to flank wall fixing. One flank wall panel is shown

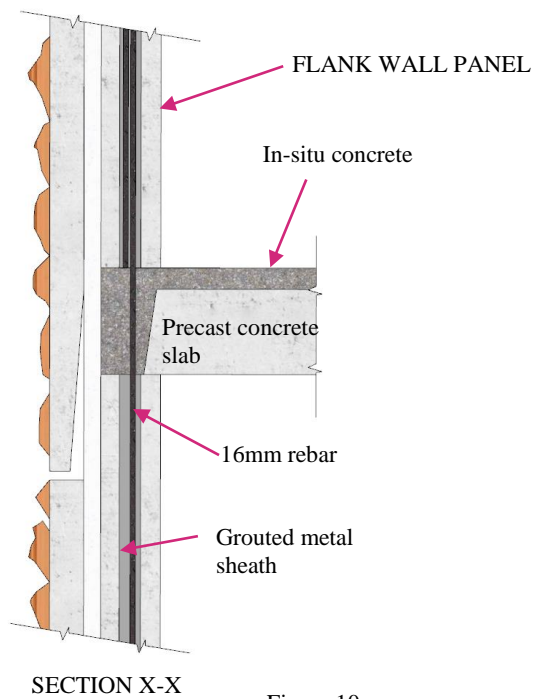
Figure 10 Flank wall to flank wall fixing, Section X-X (taken through the joint)

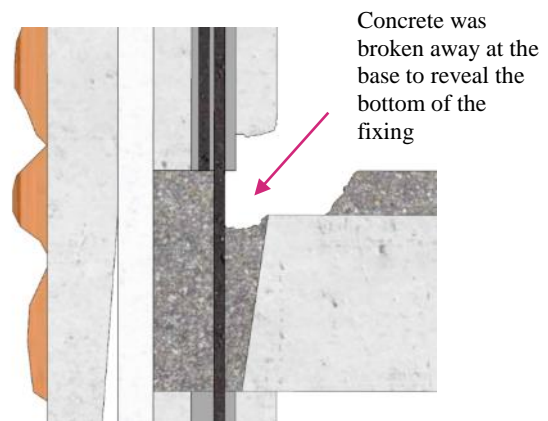
Figure 11 Flank wall to flank wall fixing, illustration of extent of break-out

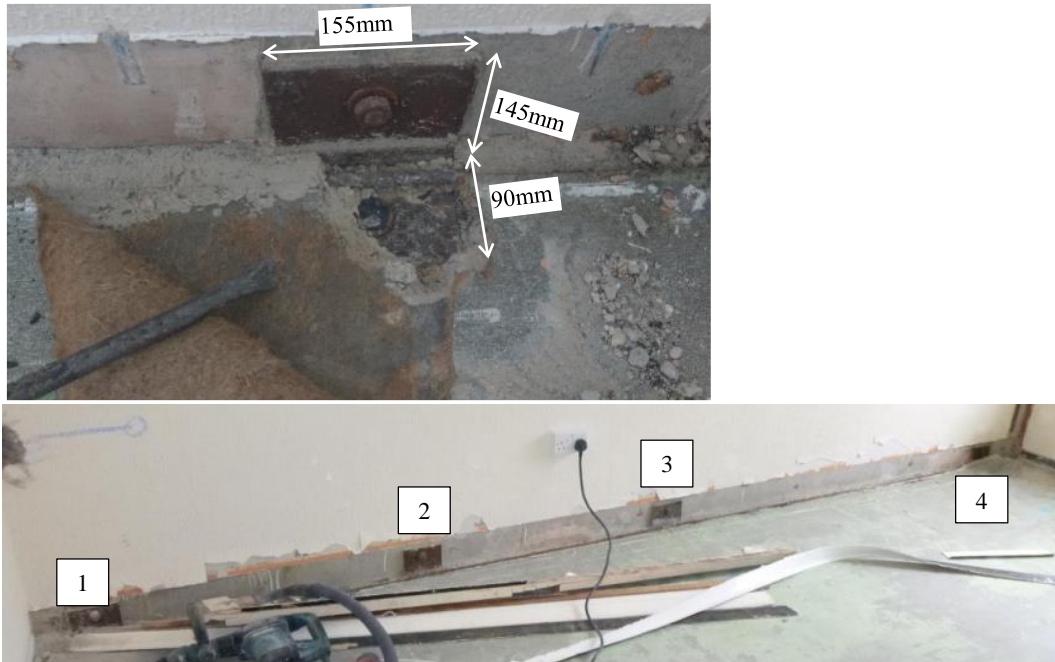
Removing the skirting boards along the base of the load-bearing cross-walls in Bromyard House revealed 10mm thick, steel L-brackets (see Figure 12) bolted to floor slabs and walls at locations 6, 7 and 8 (Figure 4). Four brackets are spaced along a length of ~5m at location 8 (Figure 12), while three brackets are spaced along a length of ~4m at locations 6 and 7. No L-brackets exist at ceiling (soffit) level. No further investigations were undertaken on these cross-walls.

Figure 12 Bromyard House – L-brackets were found along the length of the cross-walls (location 8)

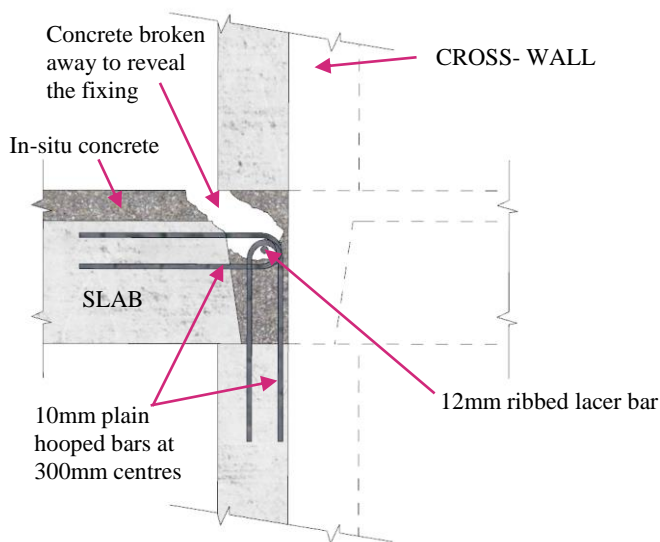
No L-brackets are present along the cross-walls in Skenfrith House. However, interlocking reinforcement at 300mm centres tying the top of the cross-wall panels to the floor slabs (similar to the flank wall fixing described in Section 3.2.4.1) was found at location 13 (Figure 4). The extent to which the joint was exposed can be seen in Figure 13. The joint was only exposed from one side, the dotted outline of Figure 13 was not investigated.

Figure 13 Skenfrith House: cross-wall to slab fixing, illustration to show extent of break-out. Only one side of the cross-wall was investigated

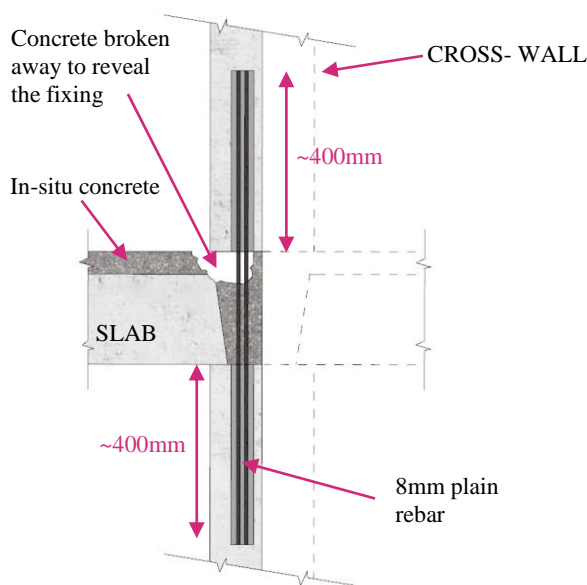
Vertical steel bars housed in grouted metal sheaths, similar to the fixing described in Section 3.2.4.2 were located in Skenfrith House. However, unlike the flank walls, the bars and sheaths only extend ~400mm above and below floor level (Figure 14), an electromagnetic scanner was used to locate the vertical bars and determine the anchorage lengths.

Only one joint was exposed, at location 13 (Figure 4), two 8mm plain vertical bars extending down into the in-situ concrete joint were found. It is unknown if the two bars extend the full height of the joint or if the bars are lapped.

Figure 14 Cross-wall to cross-wall vertical fixing. Only one side of the cross-wall was investigated

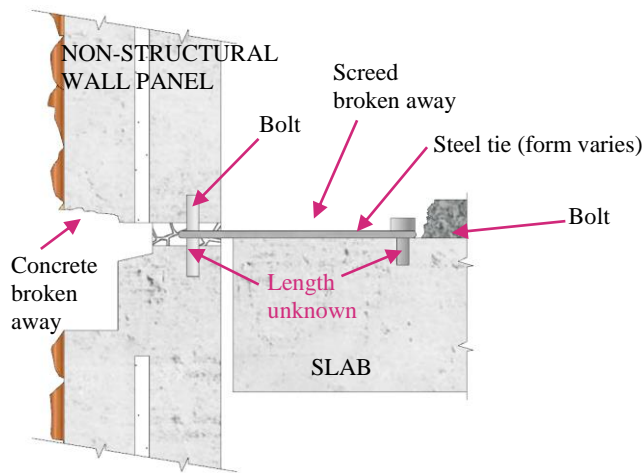
The non-structural wall panels are stacked upon each other and were not originally designed to carry vertical load, other than self-weight. They are tied back to the floor slabs with two ties per panel. Electromagnetic scans were used to locate the fixing details and two fixings (at locations 4 and 5 - Figure 4) were exposed. Different details were found at each locations (Figure 16), however the general principle is the same; the ties loop around a bolt (connecting adjacent non-structural wall panels) and are restrained via bolts to the top of the slab. The floor screed was broken away to reveal the ties from the inside and concrete was also broken away to reveal the bolt from the outside (Figure 15).

Figure 15 Non-structural wall panel to slab fixing

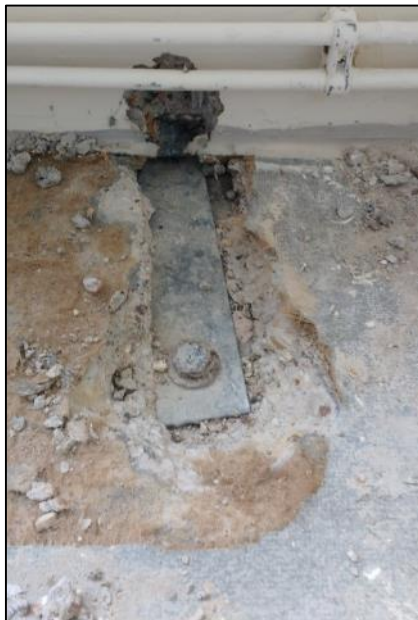
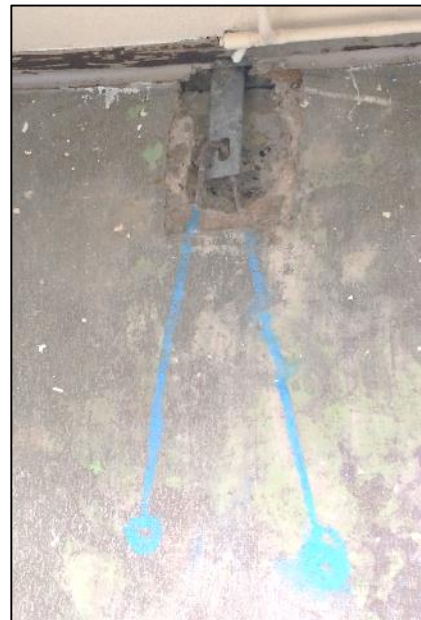
Figure 16 Non-structural wall panel to floor slab fixings exposed at locations 4 (LHS) and 5 (RHS). Chalk outline shows what the electromagnetic scanner located

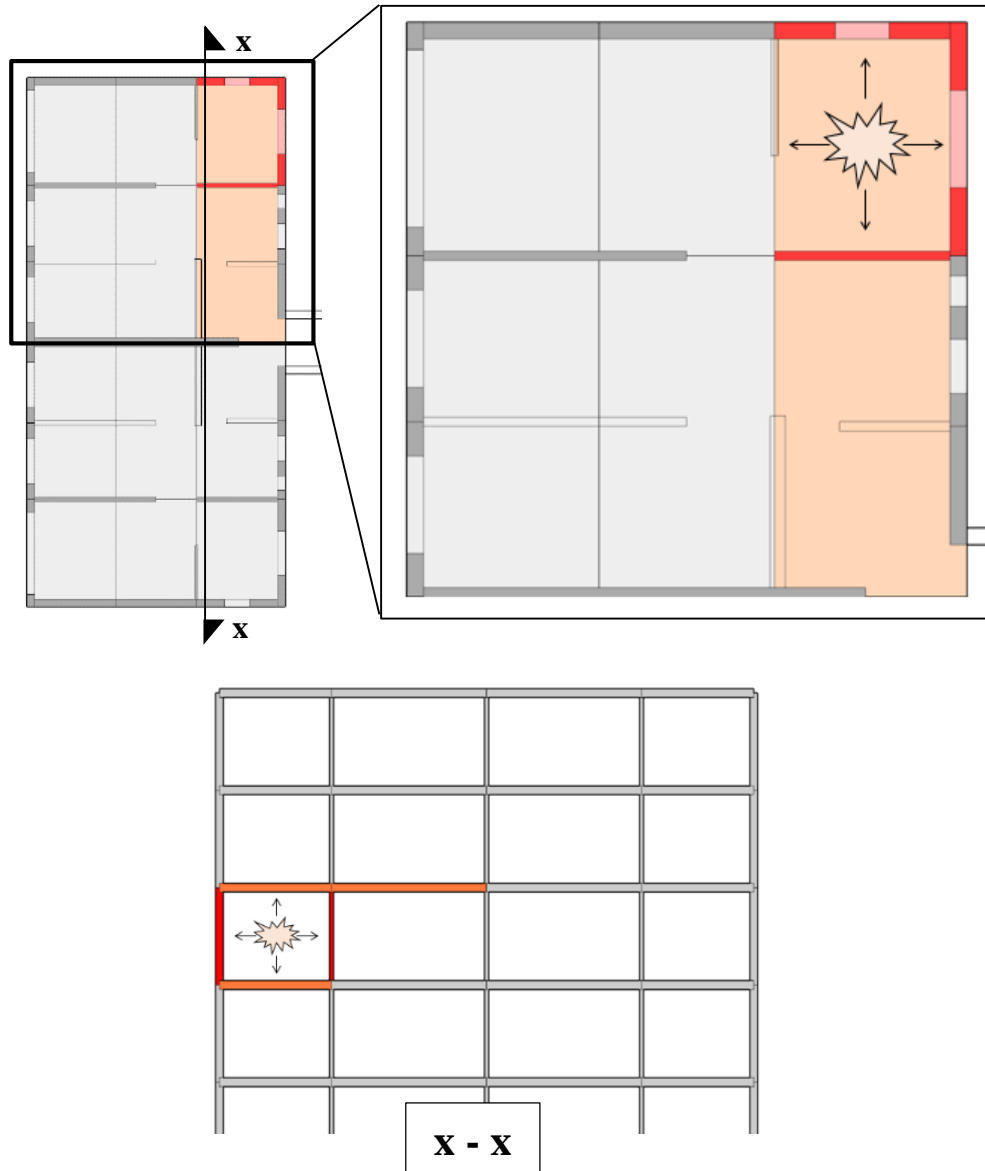
There is likely to be significant damage to the floor slabs in the room where the explosion occurs. The walls and floors that that would be affected by an explosion in the kitchen can be seen in Figure 17.

Figure 17 Plan view (above) and section view (below). The walls affected by an explosion occurring in the kitchen are highlighted in red. The affected floor slabs are highlighted in orange.

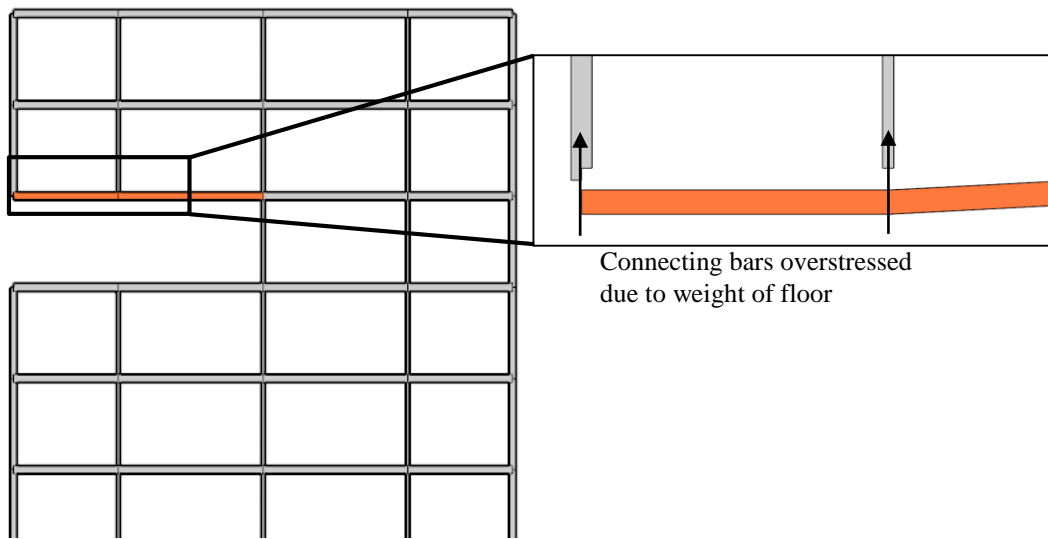
With the loss of the flank wall and the first internal wall, the floor on the level above the explosion will no longer have support from below and will try to vertically suspend from the wall above. Our investigations indicate that the floor slabs are connected to the wall below but are not directly connected to each other or to the wall above. Our investigations indicate that there are only two vertical bars per wall panel which continue from the wall panel to the wall panel above. The vertical bars are not capable of supporting the weight of the slab in tension and as such in the event of the wall failing below, then the floor previously supported by that wall would also collapse, see Figure 18. The area of the floor that would fail is greater than 15% of the total floor area (at that level) which is not compliant with the regulations for disproportionate collapse, see Figure 19.

Figure 18 With the loss of the flank wall and the first internal wall, the floor on the level above the explosion will no longer have support from below and will try to vertically suspend from the wall above. The connecting steel reinforcement bar would become overstressed due to the weight of the floor, leading to the tensile failure of this connection.

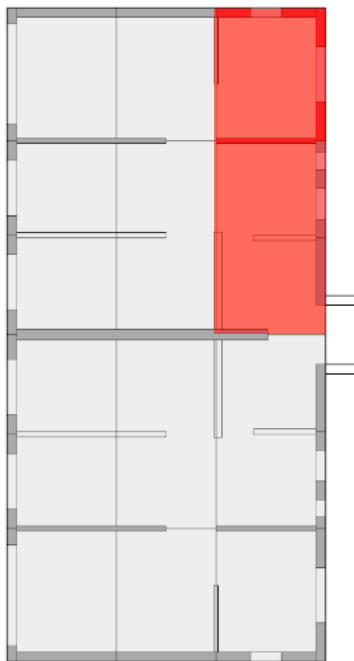
Figure 19 The area of the floor that would fail (highlighted in red) is greater than 15% of the total floor area (at that level)

It is recommended that piped gas is turned off from the tower blocks on Ledbury Estate. Note: at the time of finalising this report, the gas has already been turned off. Based on the findings of the investigations undertaken, it would be impractical to strengthen the building to accommodate piped gas. The assessment also shows that the wall panels would fail under blast pressures defined by BRE [2] for non-piped gas. It is therefore recommended that gas is not re-introduced in any form. It is further recommended that the gas pipes be removed, to ensure there will be no future use of piped gas.
