London
1 – 5 Offord Street
London N1 1DH
Telephone 020 7700 6666

design@conisbee.co.uk
www.conisbee.co.uk

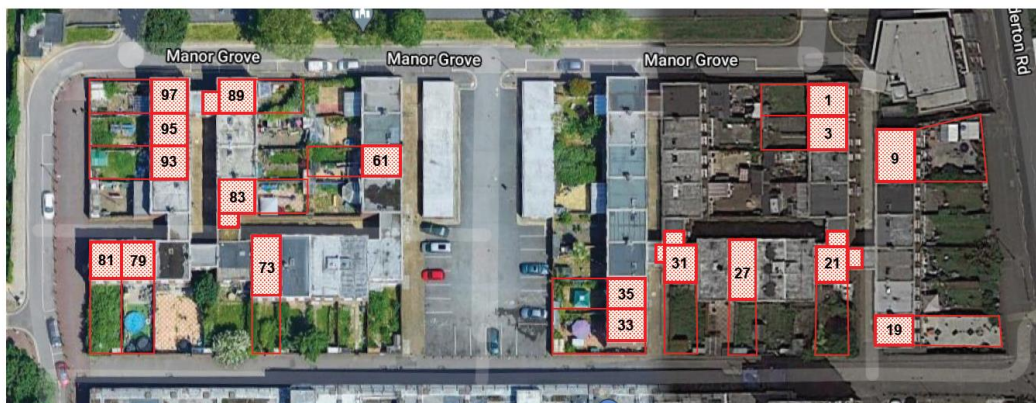
Figure 1 – Distribution of properties under the ownership of Southwark Council.

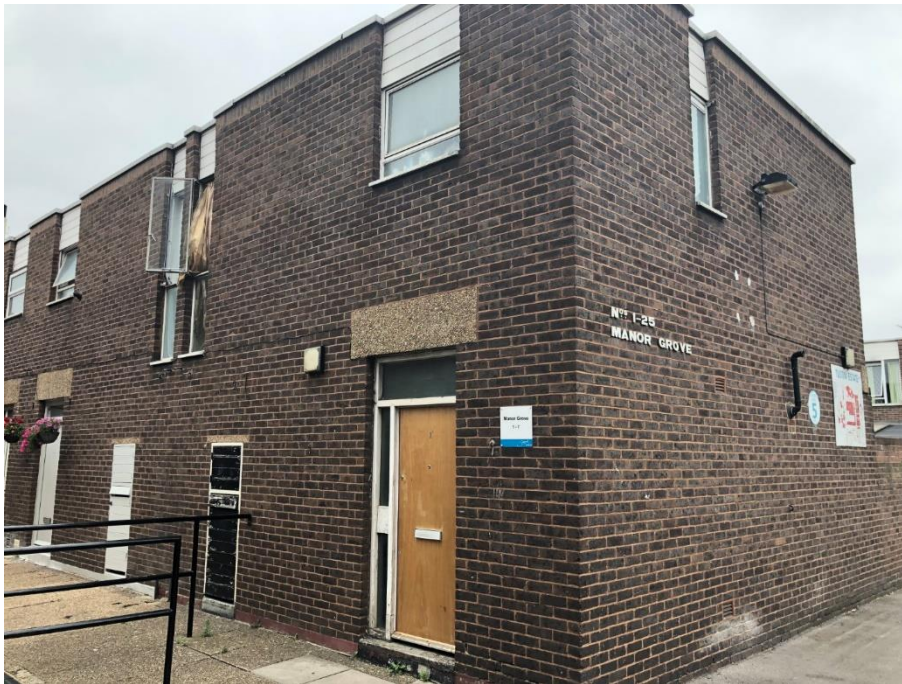
Photograph 1 – No. 1 represents a typical terraced house at Manor Grove, forming a handed pair with No. 3 beyond.

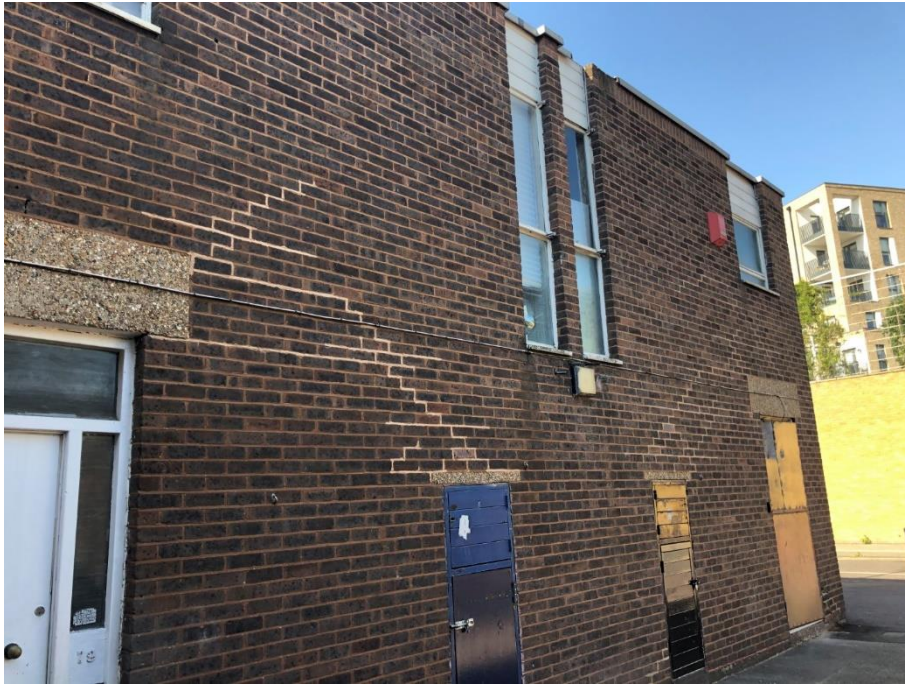
Photograph 3 – Typical pattern of cracking at Nos. 79 (near) and 81 (far).

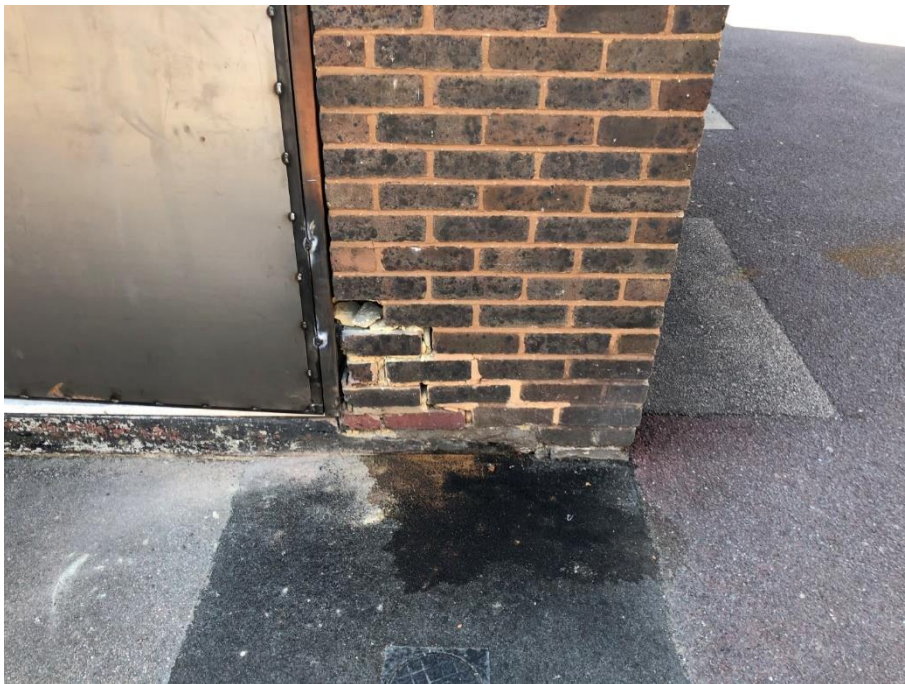
Photograph 4 – Low level brickwork cracking at No. 81.

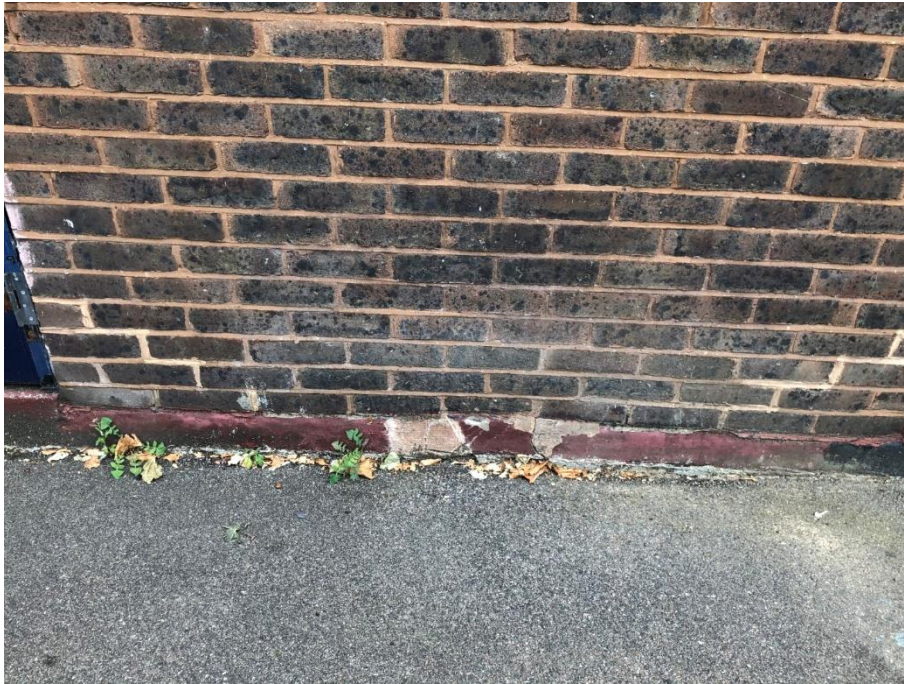
Photograph 5 – Cracking at ground level indicates junction between load bearing party wall and ground floor slabs. Note diagonal cracking to brickwork on both sides.

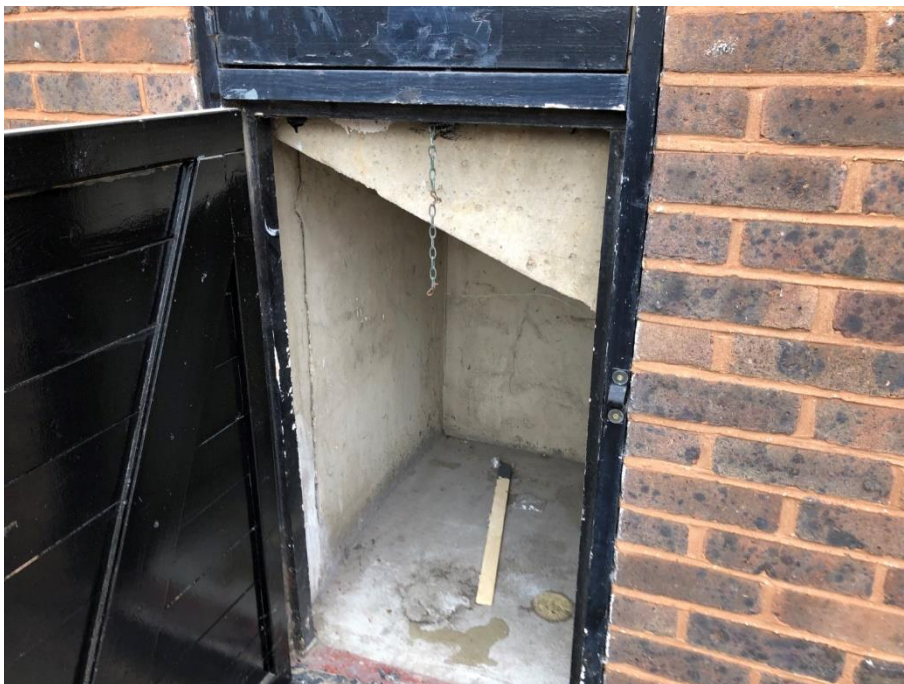
Photograph 6 – Concrete lining to under-stair cupboard. Vertical crack indicates junction with brickwork.

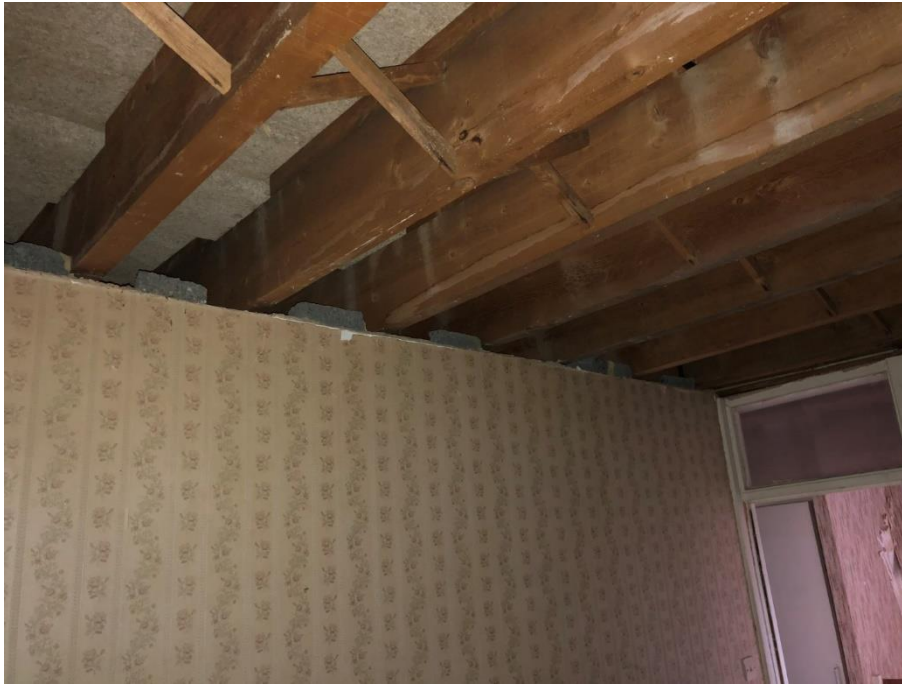
Photograph 7 – Roof structure spans between load bearing flank and party walls at No. 81. Non-load bearing blockwork partition visible.

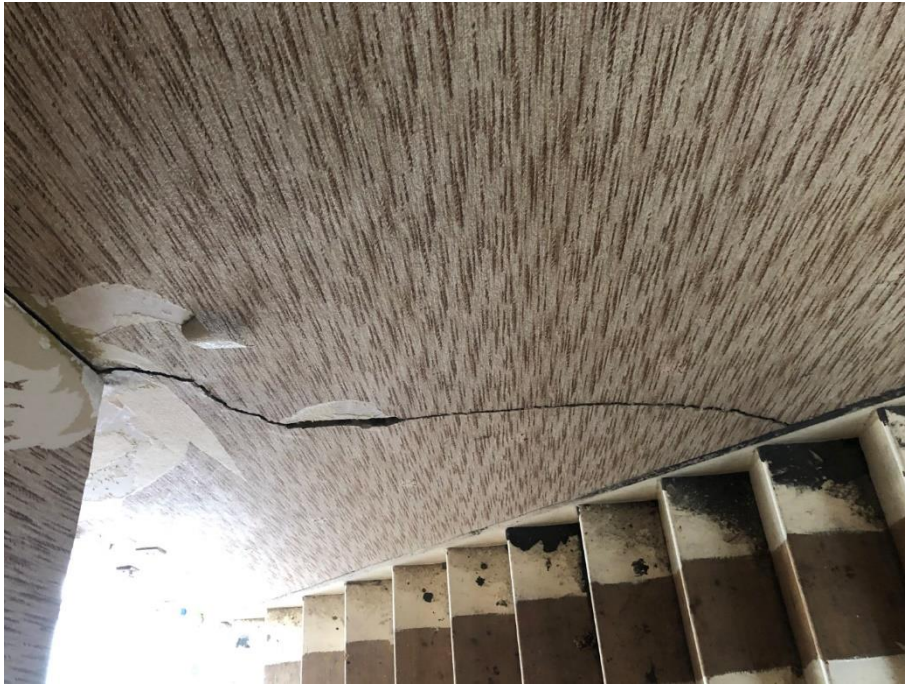
Photograph 9 – Horizontal crack across stair reflects horizontal cracks in external brickwork.

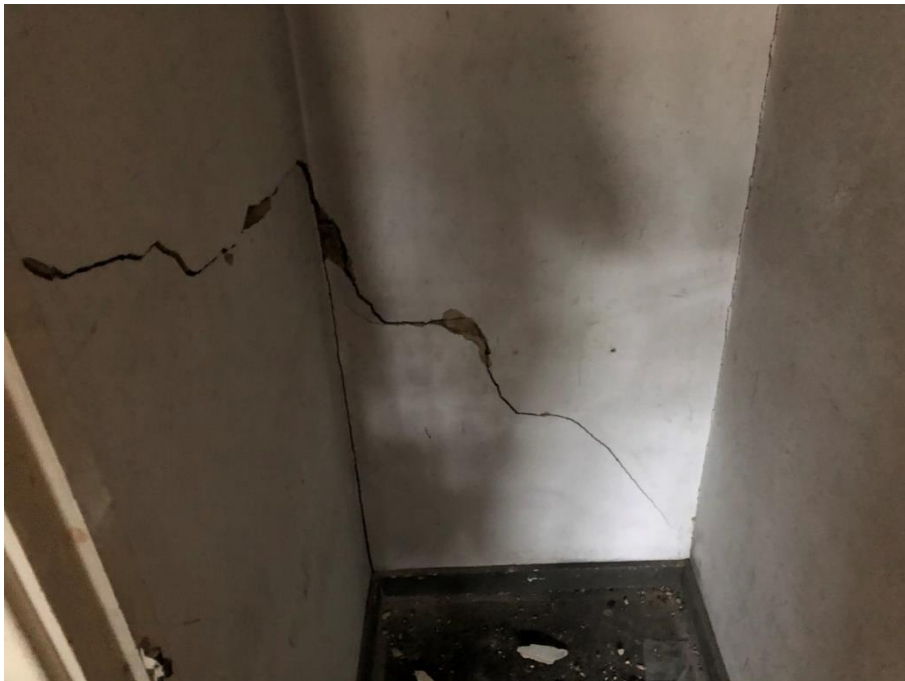
Photograph 10 – Internal cracking at understair cupboard reflects that viewed externally.

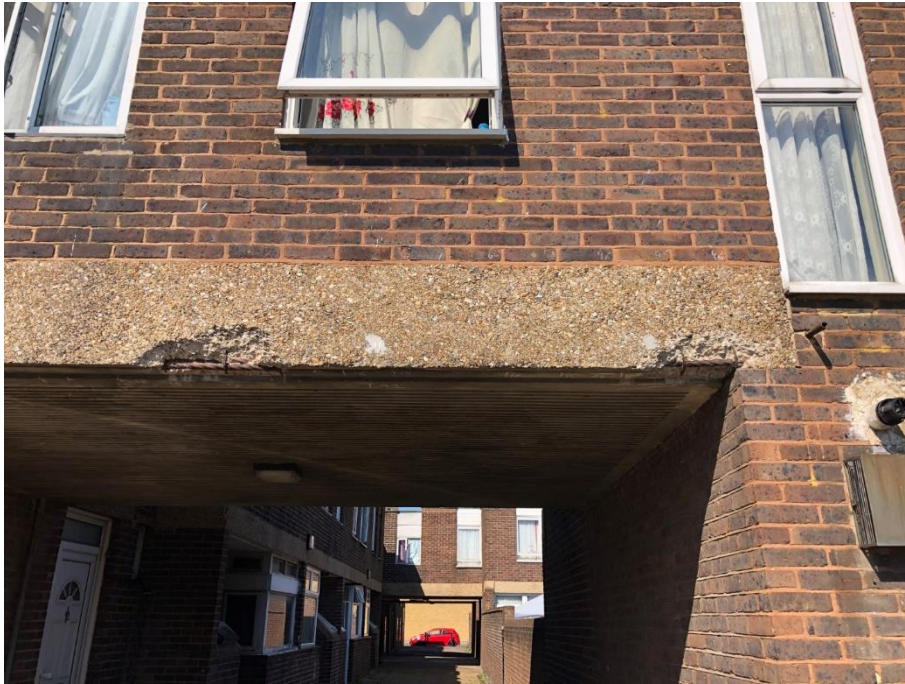
Photograph 11 – Spalling reinforced concrete slab edge.

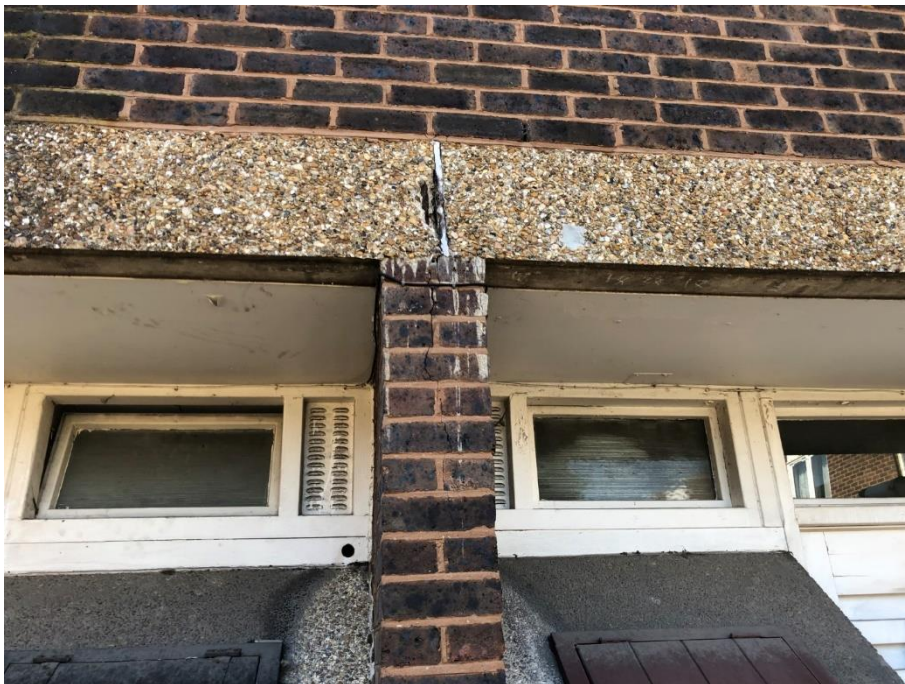
Photograph 12 – Vertical cracking through brickwork at supports to concrete elements.

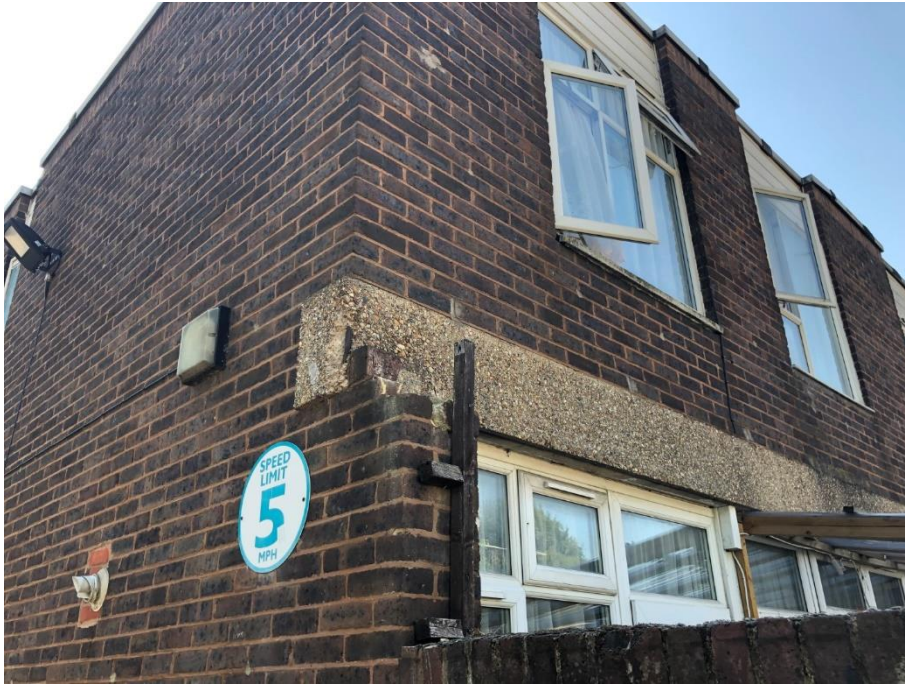
Photograph 13 – Projecting brickwork wall at supports to first floor rear beams.

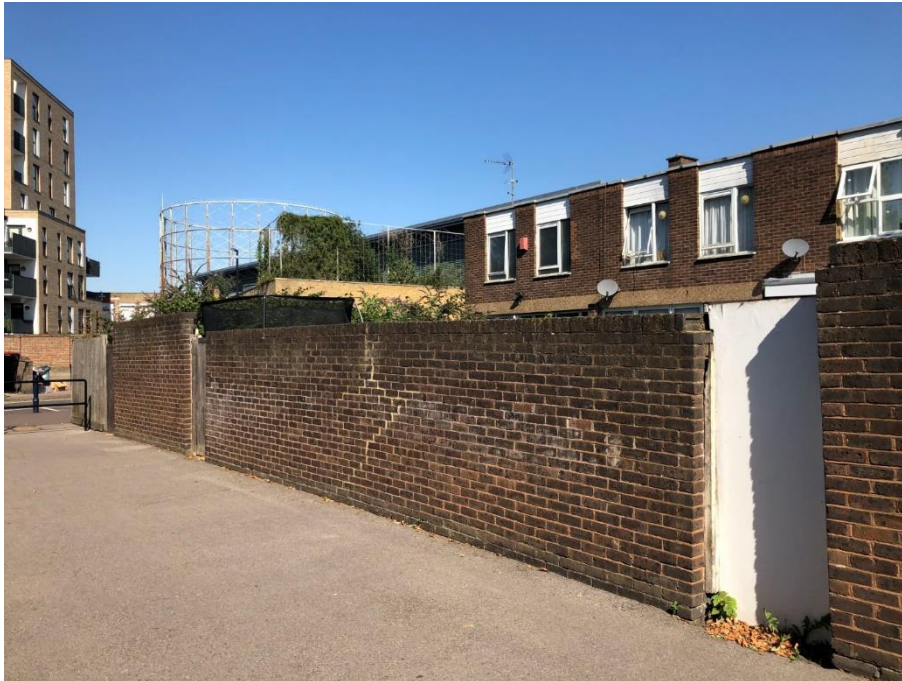
Photograph 15 – Typical cracking to boundary walls.

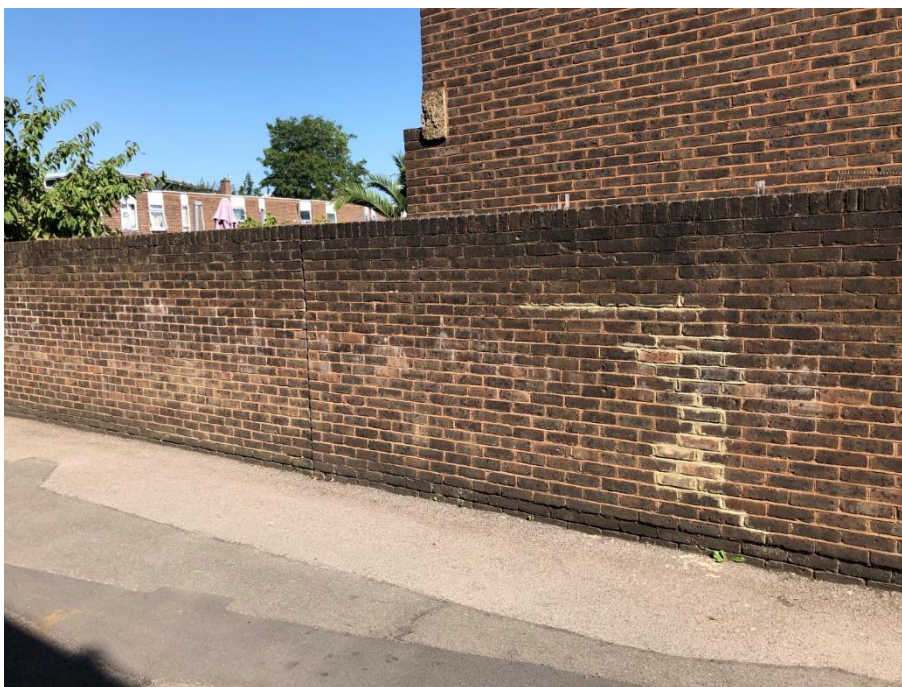
Photograph 16 – Boundary wall with movement joint. Note repair and lateral displacement at damp proof course.

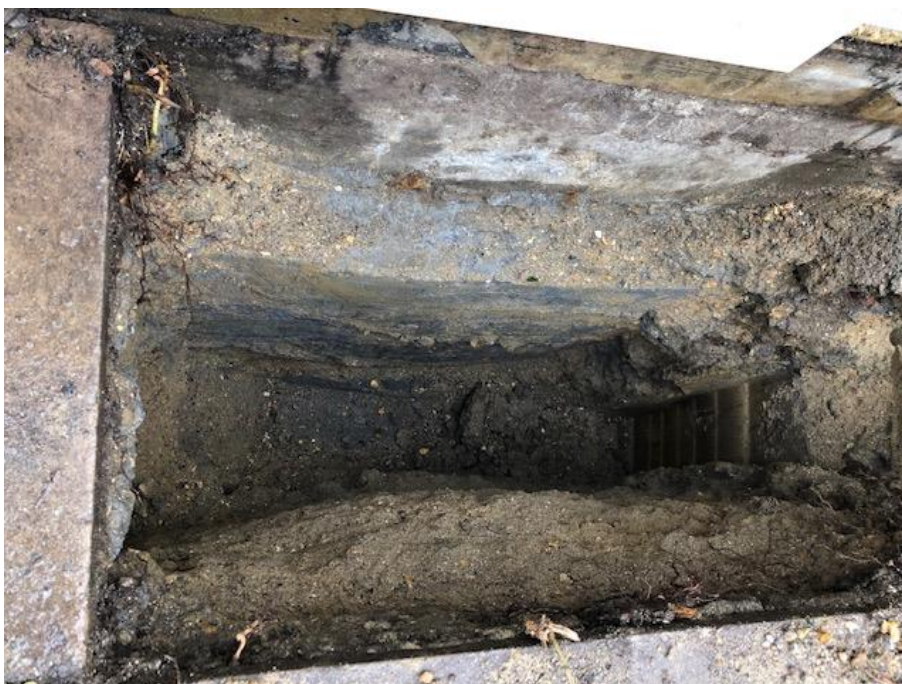
Underpinning to the rear of 81 Manor Grove

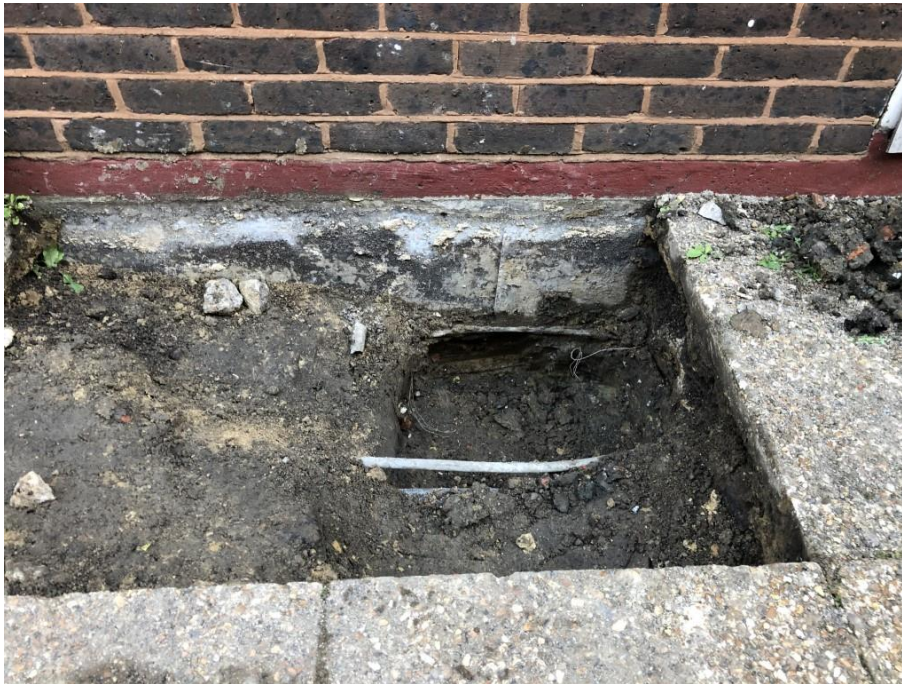
Ground slab bearing on made-up ground at 83 Manor Grove

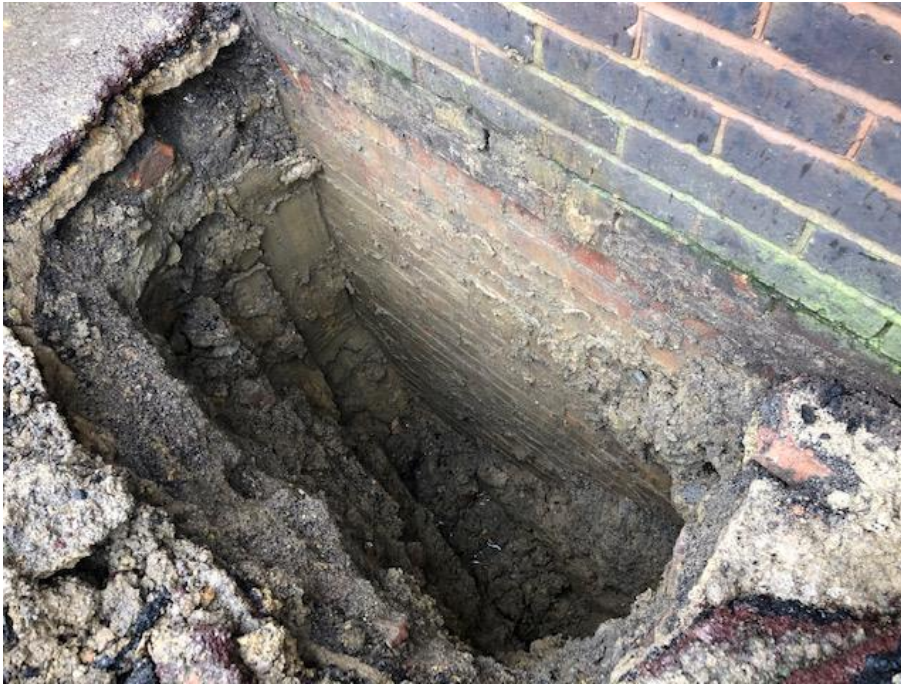
Deep foundations to the flank wall of 81 Manor Grove.

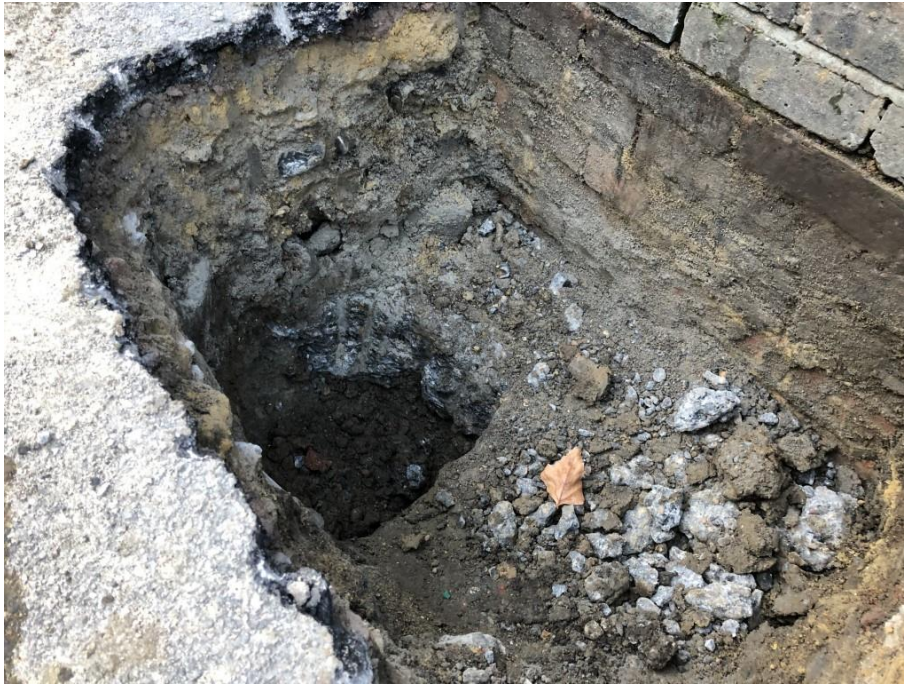
Shallow footing to the garden wall at the south side of Manor Grove, on the boundary with Kentmere House.

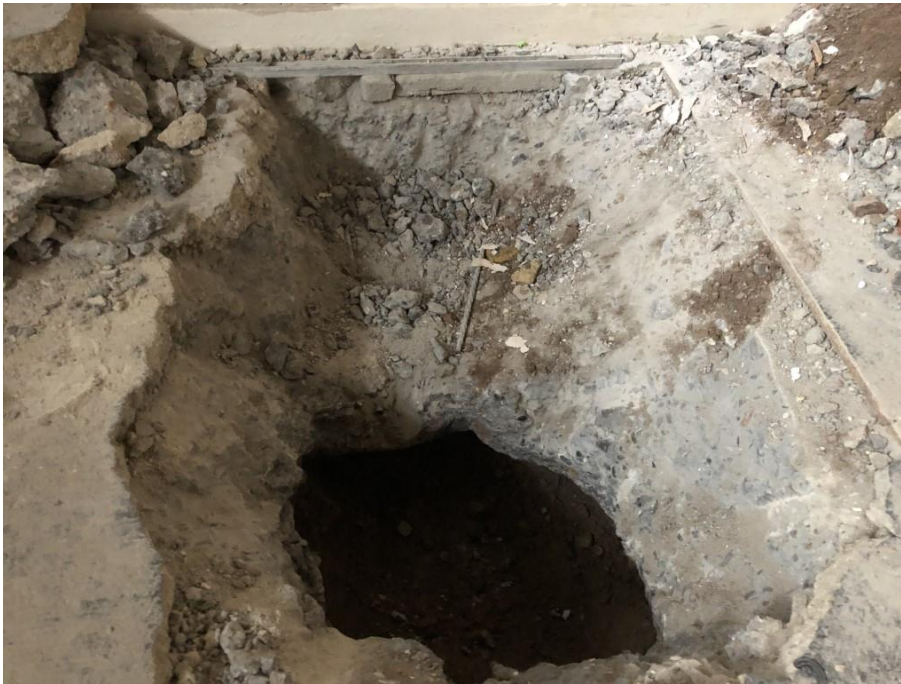
Internal trial pit carried out at 81 Manor Grove
