**Ledbury Estate**

Structural Assessment of Bromyard,  
Peterchurch, Sarnsfield and Skenfrith  
House

Issue | 20 November 2017

Job number 245112-05

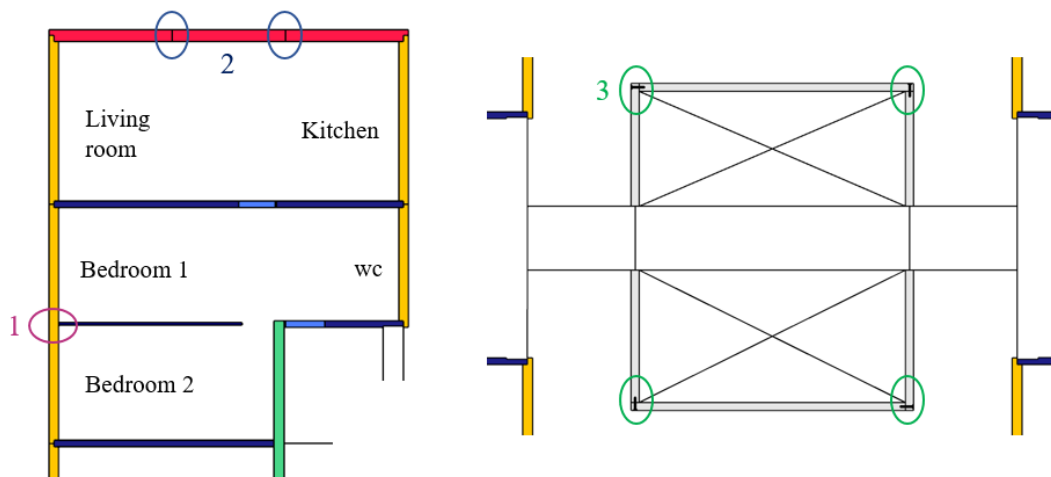
‘Cracks’ up to 30mm wide reported were reported by both residents and surveyors. Crack patterns are repeated throughout the tower blocks with the largest cracks always occurring in the same position (between the external wall panels and intermediate cross-wall separating the two bedrooms, location 1, Figure 6.

1. Gaps between the external wall panels and internal walls and floors, location 1, Figure 6
2. Gaps between adjoining precast concrete panels, location 2, Figure 6
3. Gaps between the precast staircase landings and the external stairwell walls, locations 3, Figure 6

Figure 6 Approximate floor-plan of a two-bedroom flat; locations of the primary ‘cracks’ reported are marked (LHS). Approximate floor-plan of the lift and stair core, showing the locations of the primary ‘cracks’ reported (RHS)

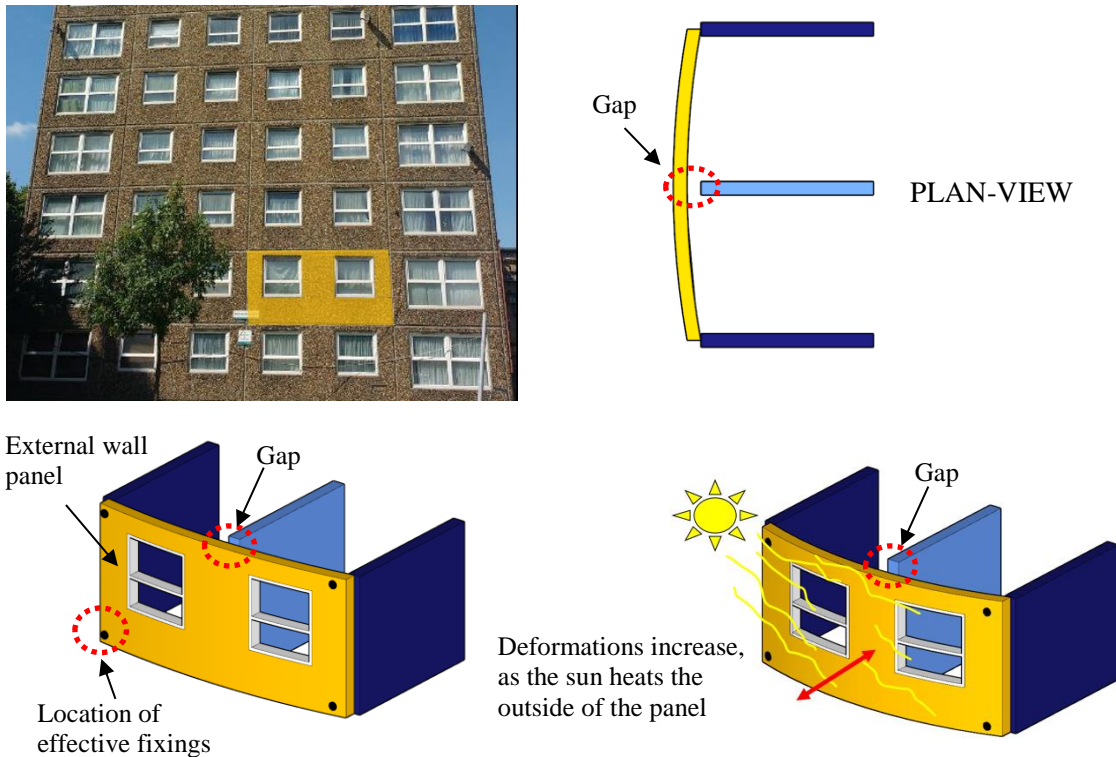
gaps to form over the full storey height between the centre of the bowed panel and intermediate cross-walls. Horizontal gaps also form between the external wall panels and the floor slabs. Additionally, temperature changes cause the gaps to further open/close, see Figure 7.

This is consistent with what has been reported by residents (gaps have been present for 17+ years and open and close depending on weather conditions) and is also consistent with gaps reported between the external wall panels and the internal walls in the 1985 BRE report [1].

Figure 7 Floor to ceiling vertical gap between the intermediate cross-walls and the external wall panels

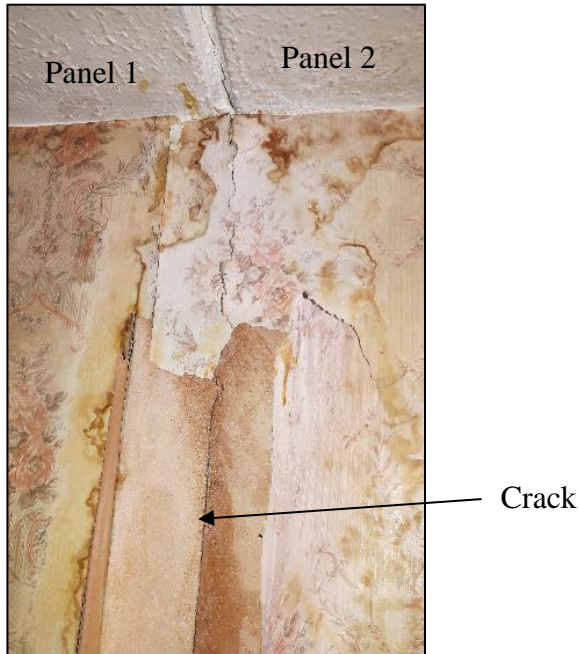
Cracks occur in the internal finishes (plaster/paint) where two precast concrete panels meet e.g. at location 2, Figure 6. An example of this can be seen in Figure 8.

All buildings move slightly due to thermal movements and wind. The building is made from large panels, made in a factory, small movements between those panels is to be expected.

Figure 8 Cracks occur in the internal finishes (plaster/ paint) where two precast concrete panels meet

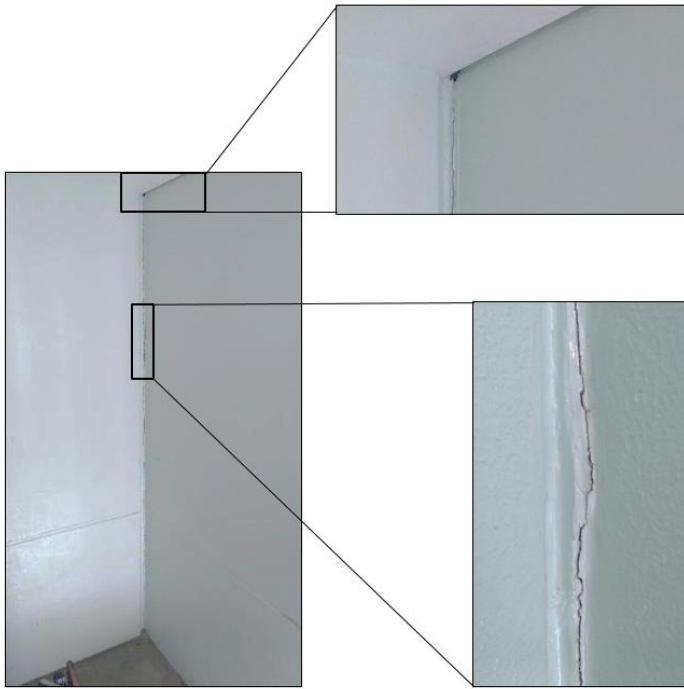
Gaps have opened up at the corner of the stairwell where two panels meet, see Figure 9. The horizontal gaps between the staircase landings and the walls is typically 5-6mm.

Figure 9 Gaps between adjacent wall panels in the lift and stair cores

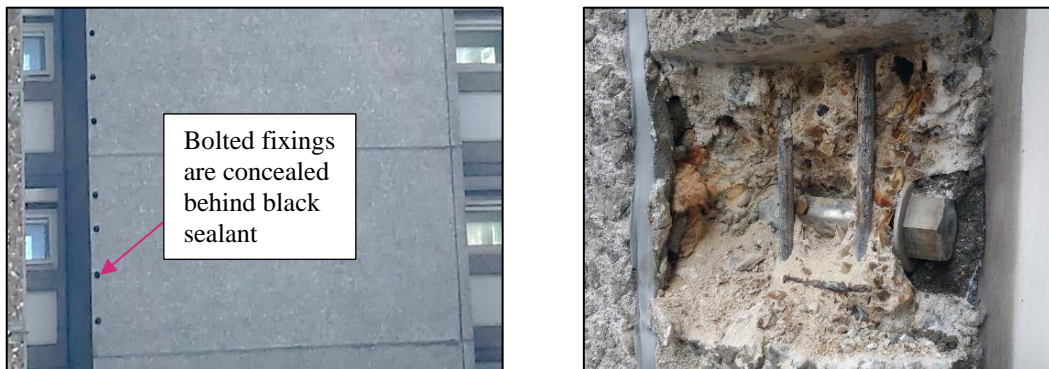
Three of the fixings bolts were exposed by breaking away the surrounding concrete, see Figure 10. These were exposed on Bromyard, Sarnsfield and Peterchurch House.

Stainless steel bolts, 34mm in diameter, sitting in slightly oversized holes (by 5-6mm) were exposed. The fixings and the surrounding reinforcement cage were found to be in very good condition, with no evidence of corrosion.

Figure 10 Fixings bolts are concealed behind black sealant (LHS). Fixing bolt exposed by breaking away surrounding concrete (RHS)

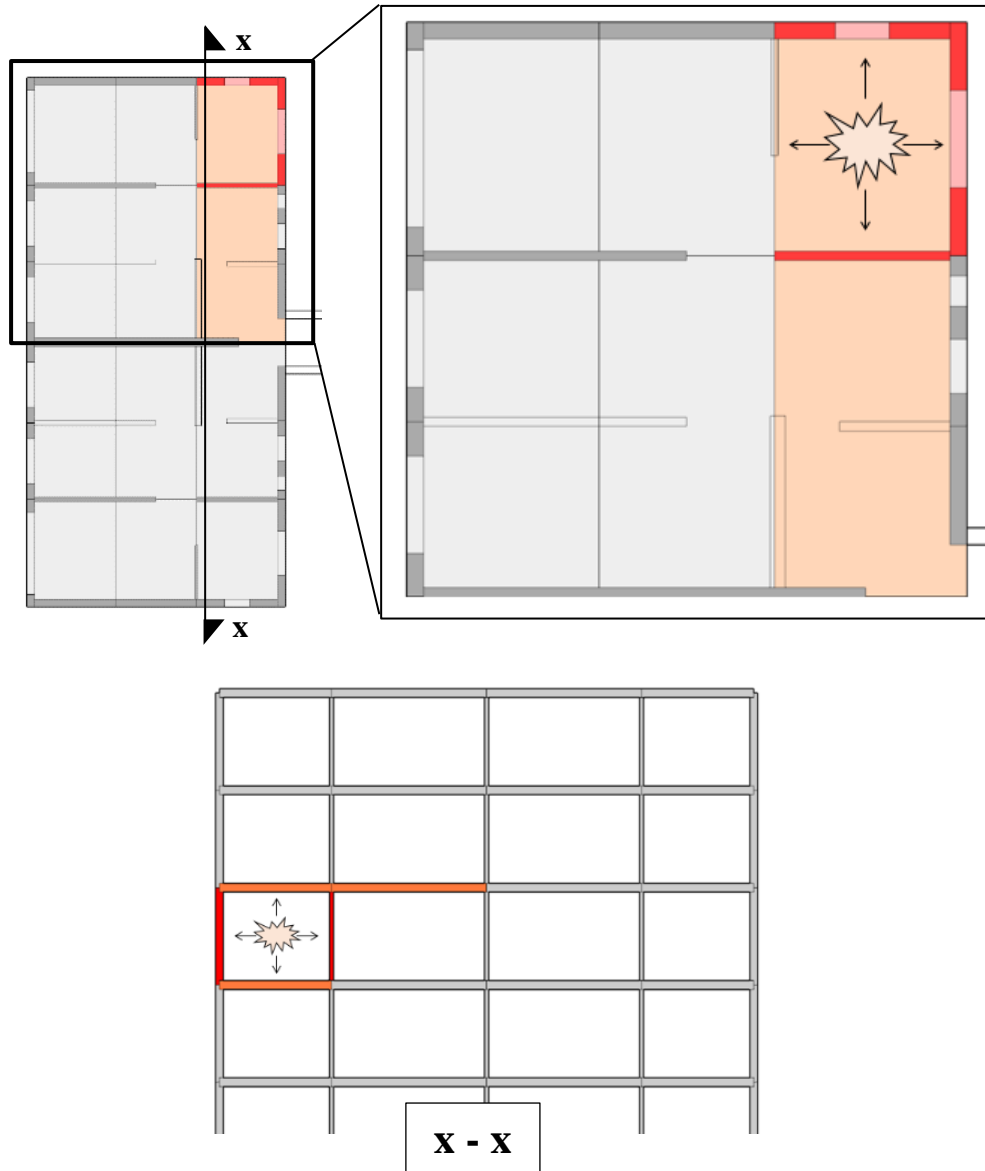
Our investigations indicate that the flank have minimal reinforcement\*, while the cross-walls are unreinforced concrete. As such the walls do not have sufficient capacity to resist 34kPa (accidental load requirement for a block with piped gas) or 17kPa (accidental load requirement for a block with bottled gas) and as such the walls surrounding the explosion will fail. This has consequences to the floor immediately above which relies on the walls for support.

There is likely to be significant damage to the floor slabs in the room where the explosion occurs. The walls and floors that that would be affected by an explosion in the kitchen can be seen in Figure 13.

Figure 13 Plan view (above) and section view (below). The walls affected by an explosion occurring in the kitchen are highlighted in red. The affected floor slabs are highlighted in orange.

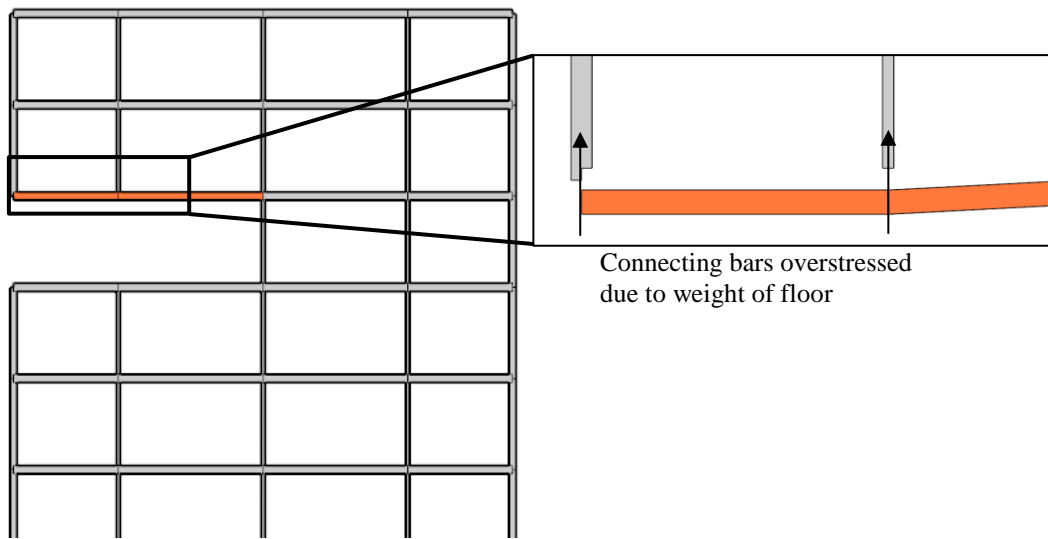
With the loss of the flank wall and the first internal wall, the floor on the level above the explosion will no longer have support from below and will try to vertically suspend from the wall above. Our investigations indicate that the floor slabs are connected to the wall below but are not directly connected to each other or to the wall above. Our investigations indicate that there are only two vertical bars per wall panel which continue from the wall panel to the wall panel above. The vertical bars are not capable of supporting the weight of the slab in tension and as such in the event of the wall failing below, then the floor previously supported by that wall would also collapse, see Figure 14. The area of the floor that would fail is greater than 15% of the total floor area (at that level) which is not compliant with the regulations for disproportionate collapse, see Figure 15.

Figure 14 With the loss of the flank wall and the first internal wall, the floor on the level above the explosion will no longer have support from below and will try to vertically suspend from the wall above. The connecting steel reinforcement bar would become overstressed due to the weight of the floor, leading to the tensile failure of this connection.

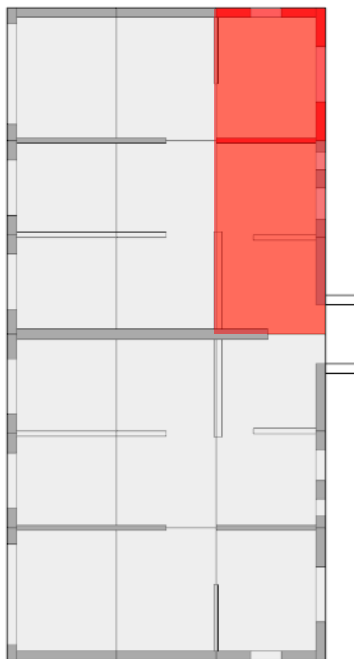
Figure 15 The area of the floor that would fail (highlighted in red) is greater than 15% of the total floor area (at that level)
