THI project: The Old Crown Hotel repaired and restored 2017 - 2019

THI Project: The Red Bull repaired and restored 2017 - 2019

THI Project: Filishack repaired and restored 2017 - 2019

THI Project: Acuherbal repaired and restored 2018 - 2021

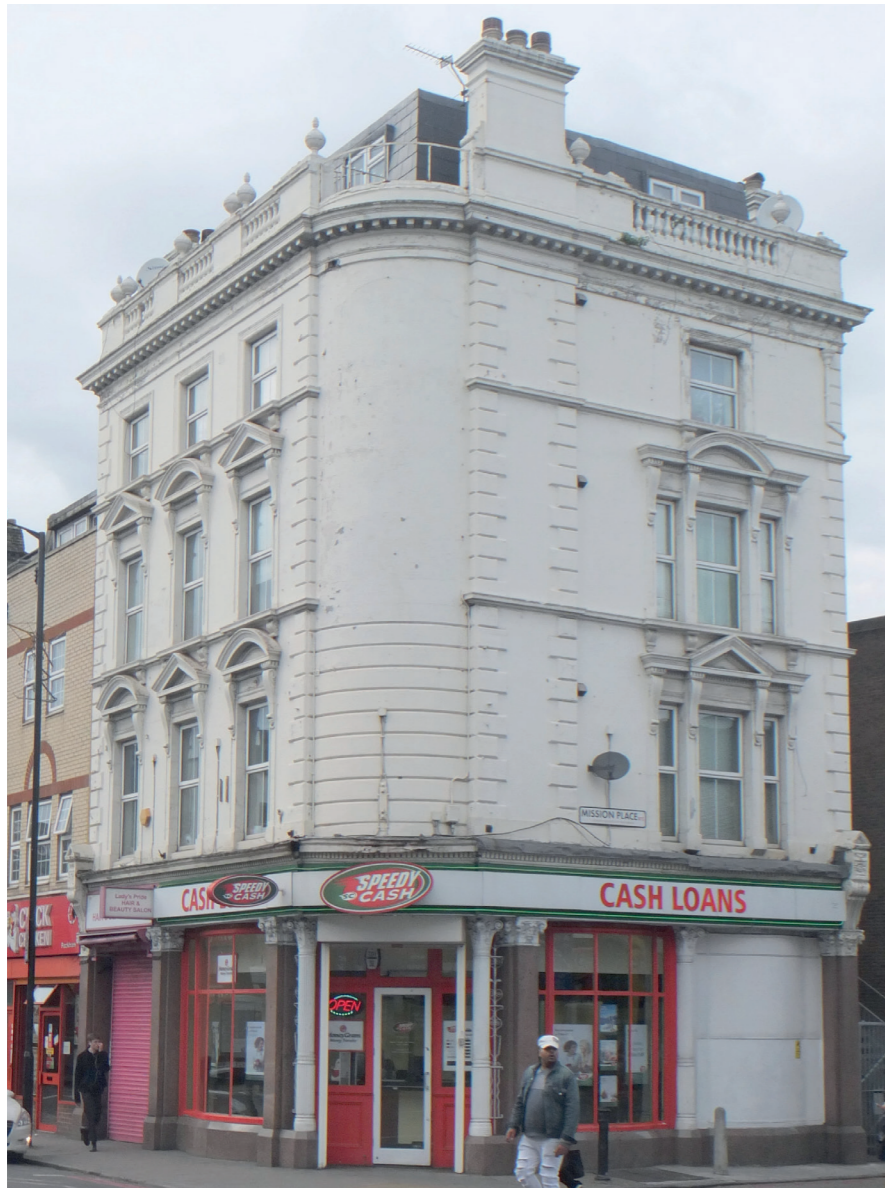
2017, before works

This converted pub was formerly known as The Old Crown Hotel. A pub has been on this site since 1830, and this pub was built in 1891. By the early 21st century the building was converted into two shop units, with flats above. The building was covered in clutter, including satellite dishes and odd signs, and was in poor condition.

Through the THI, we restored the richly decorated exterior of the building above the shop front. The upper cornice and elaborate parapet balustrade, ornamented with urns, was in poor condition. Missing urns and baluster bottles were restored or repaired.

The distinctive window surrounds and rusticated (bold horizontal lines) quoins on the corners had been damaged, and before the fronts were redecorated, all the decayed parts of the building were repaired and made weathertight. New windows were installed.

A new timber shop-front and entrance door to the corner was made to suit the original proportions of the existing timber windows to the main and side streets. Once on site, a stained glass window was discovered, which was used to prepare a replica design and wording for new stained-glass panels.

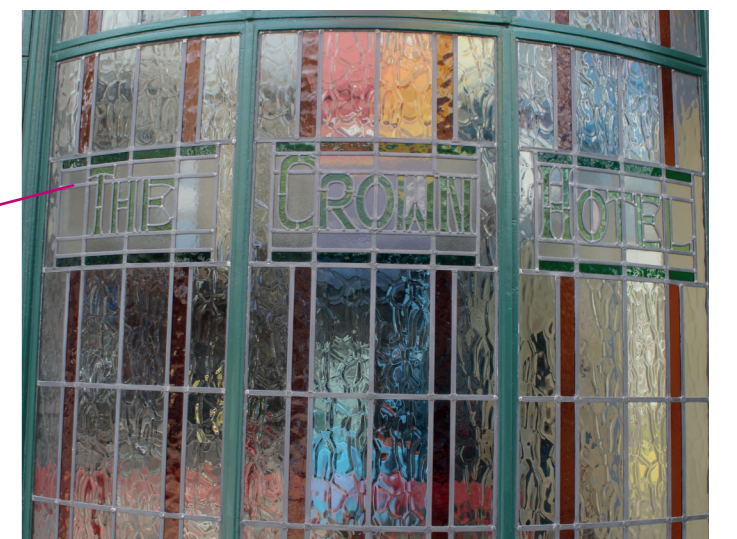
replicating the shopfront leaded light window

The condition of the salvaged stain glass showed it had already been repaired and fixed since its original conception. We were able to identify the original details and replicate them in new panels which will last longer than partial repairs.

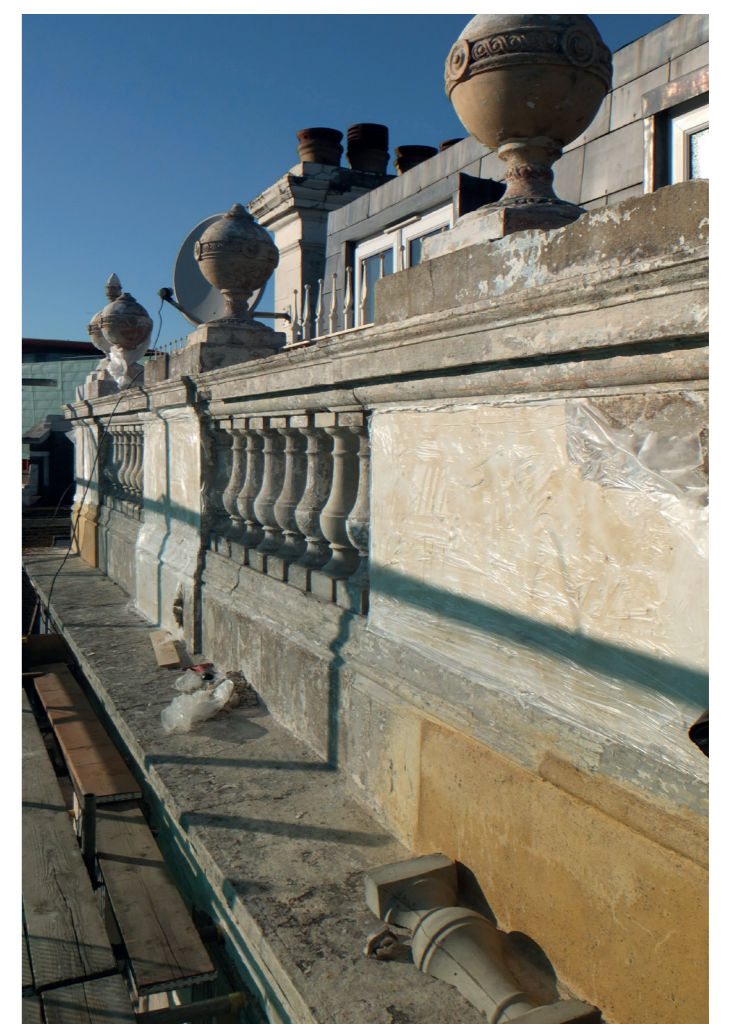
restoration and redecoration works to the parapet balustrade finials

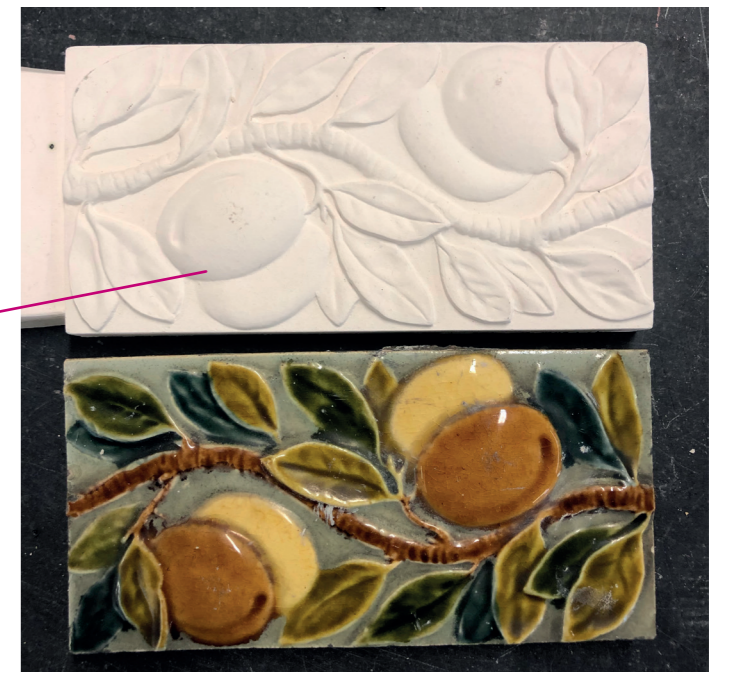
replicating the frieze tiles and decoration works to the fascia

We installed a new shopfront, with stall risers clad in Balmoral granite to match the existing pilasters. The upper storey brickwork was carefully repaired and repointed with lime mortar. Satellite dishes and other clutter fixed to the building and damaged or missing items were restored or replaced. Works included replacing a missing section of decorative cast ironwork, and repairing the deep parapet cornice. We also installed a small delicate tile frieze that was missing, which was remade by hand and replaced.

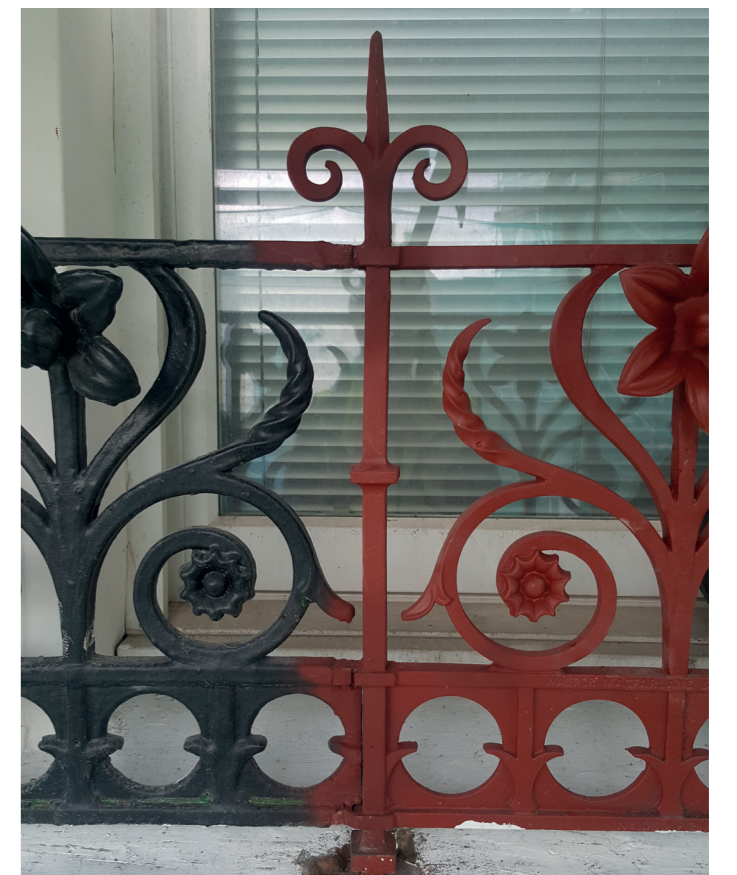
restoration works to the missing decorative cast ironwork

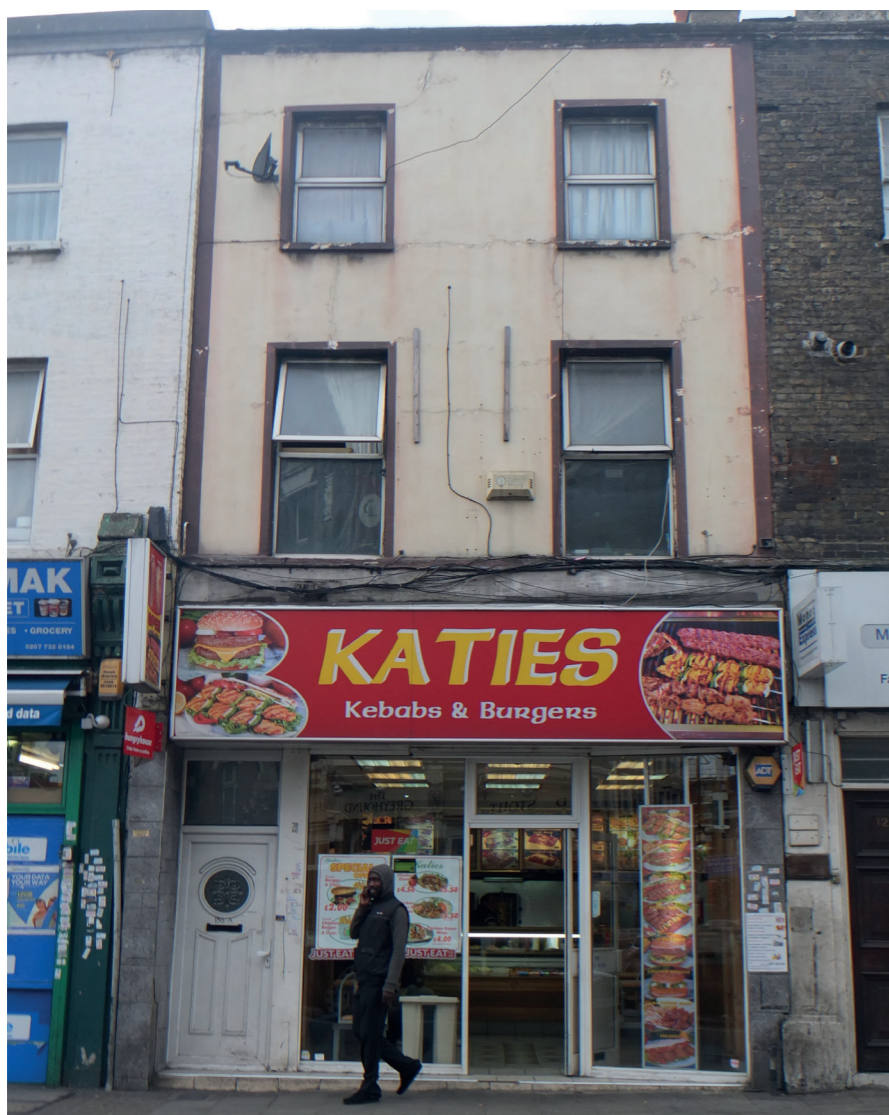
2017, before works

Part of Shard's Terrace (91 – 107 Peckham High Street, and 126 – 130 Peckham Hill Street), this building dates back to the early 19th century, and has survived the road widening of 1880 – 82. A comprehensive package of repair and restoration works was carried forward to improve the building's condition and restore its appearance. This included reinstating lost and damaged historical features. This returned some of the features that give special architectural character to Shard's Terrace. 20th century render on the front of the building was removed and new 'breathable' render and finish was applied. The parapet cornice was restored, and the roof covering was extensively repaired and upgraded with new slates and lead surround.

A new timber shopfront and sliding sash windows were made to fit carefully into the existing openings. An internal shallow ramp has created level access between the shop unit and the street.

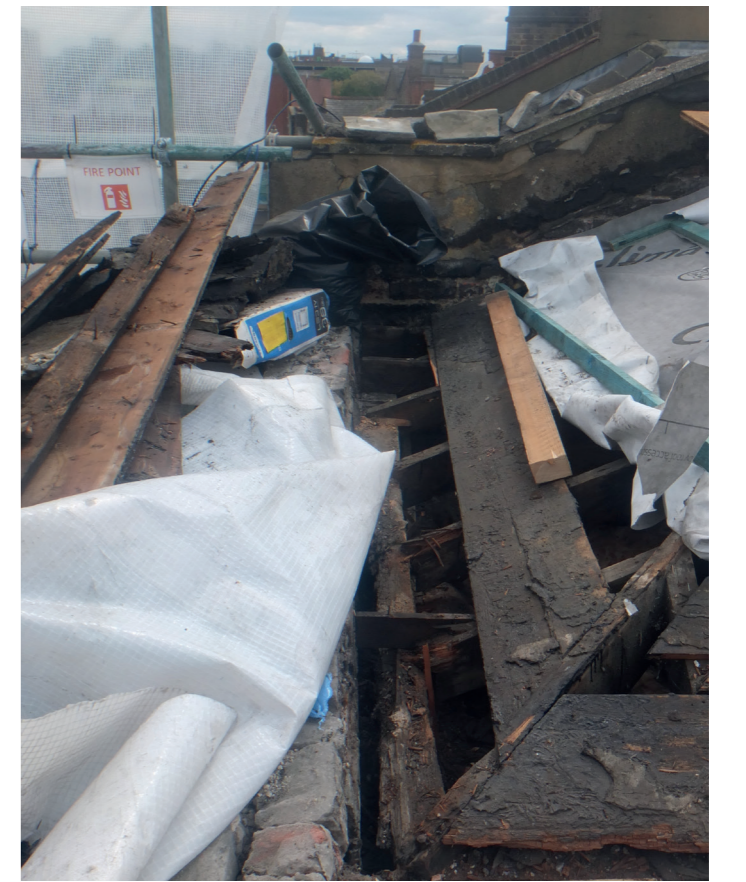
exposing the roof condition behind the parapet

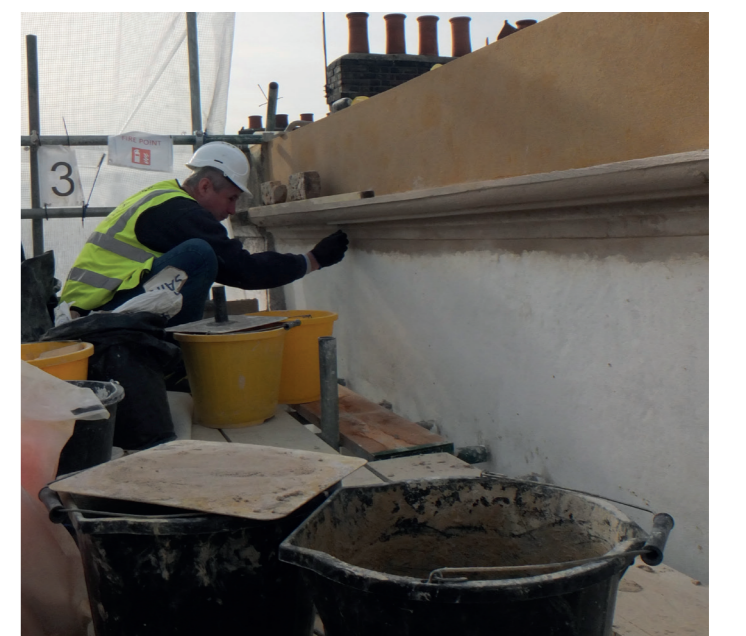
restoration works to the upper cornice

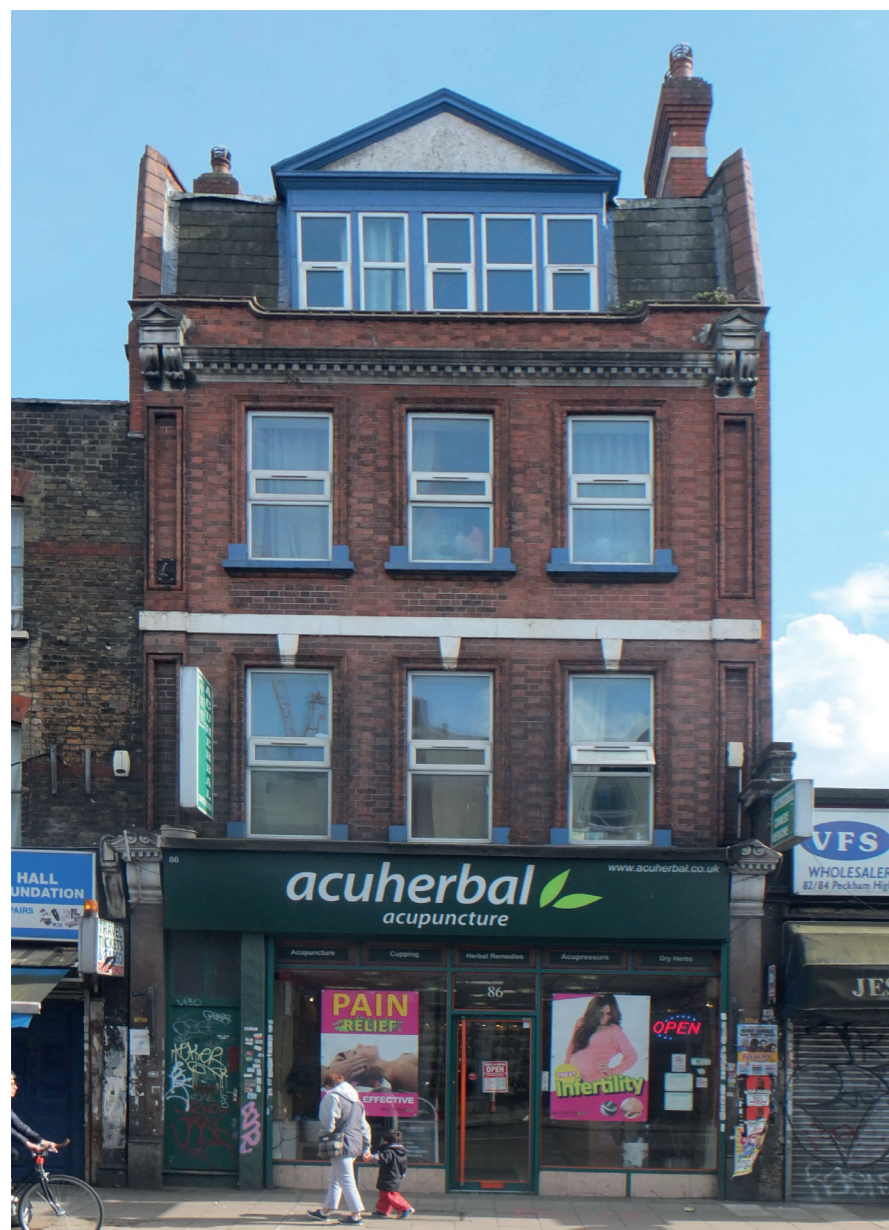
2017, before works

This is a handsome late Victorian red brick building. At ground level, the original granite pilasters had been damaged, and the Portland stone capitals were fractured. The brickwork was sooted and the window sills were unsuitably decorated. The sash windows had been replaced with PVC, and a separate residential access was in poor condition.

The brickwork to the front of the building was gently cleaned. At the same time, the pair of carved Portland stonework capitals at high level, and the attic storey pediment, were cleaned. At first floor level, the plain stone band and the head of the first-floor window keystones were stripped of flaking paint, and delicate repairs to the stonework were carried out.

We replaced a weakened basement steel support, so the new timber shopfront sits on a new structural beam with new concrete pavement light in front of the building. A new residential door and dividing pilaster has been added. New timber windows have been installed.

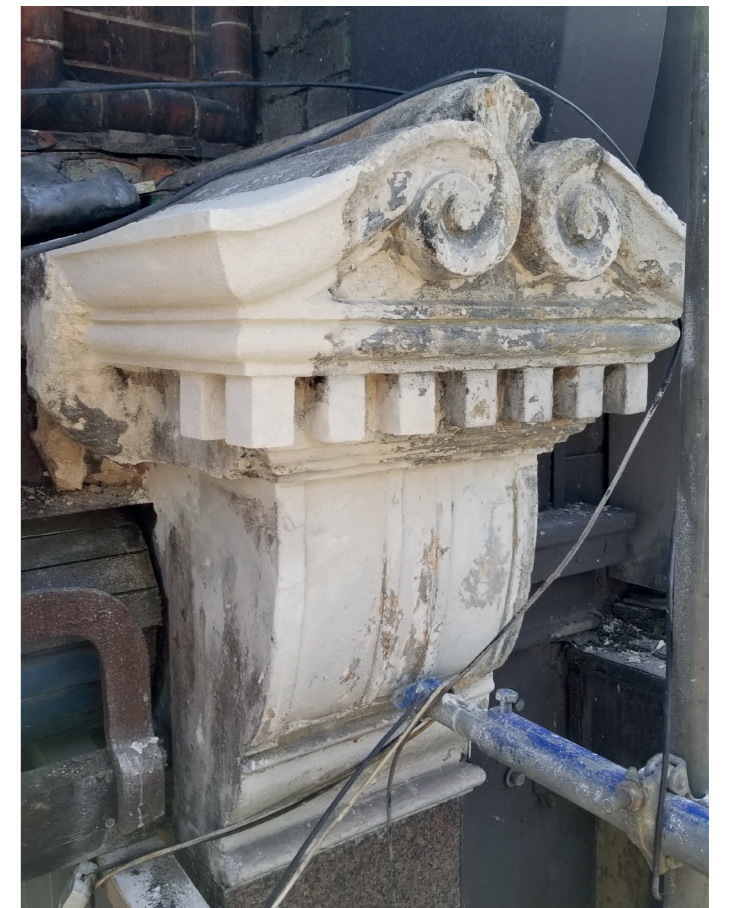
restoration works to the Portland stone capitals

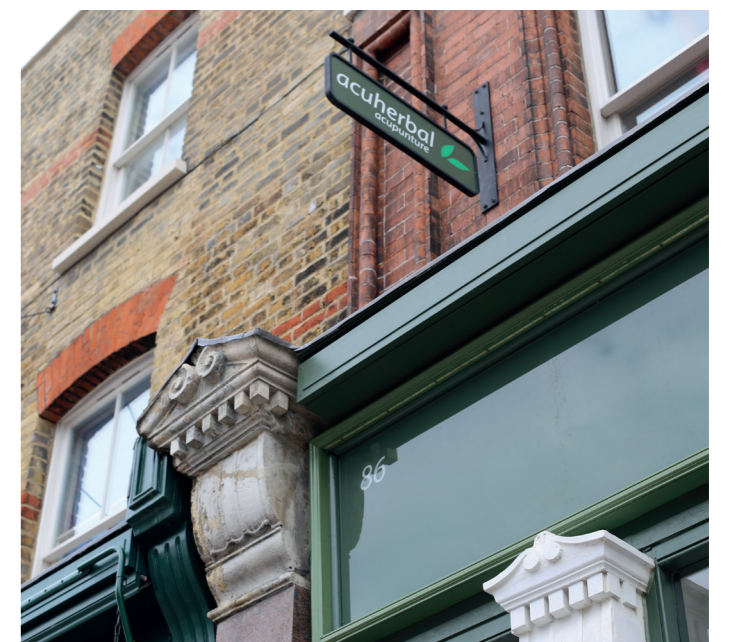
upclose view of the new shopfront features as a whole

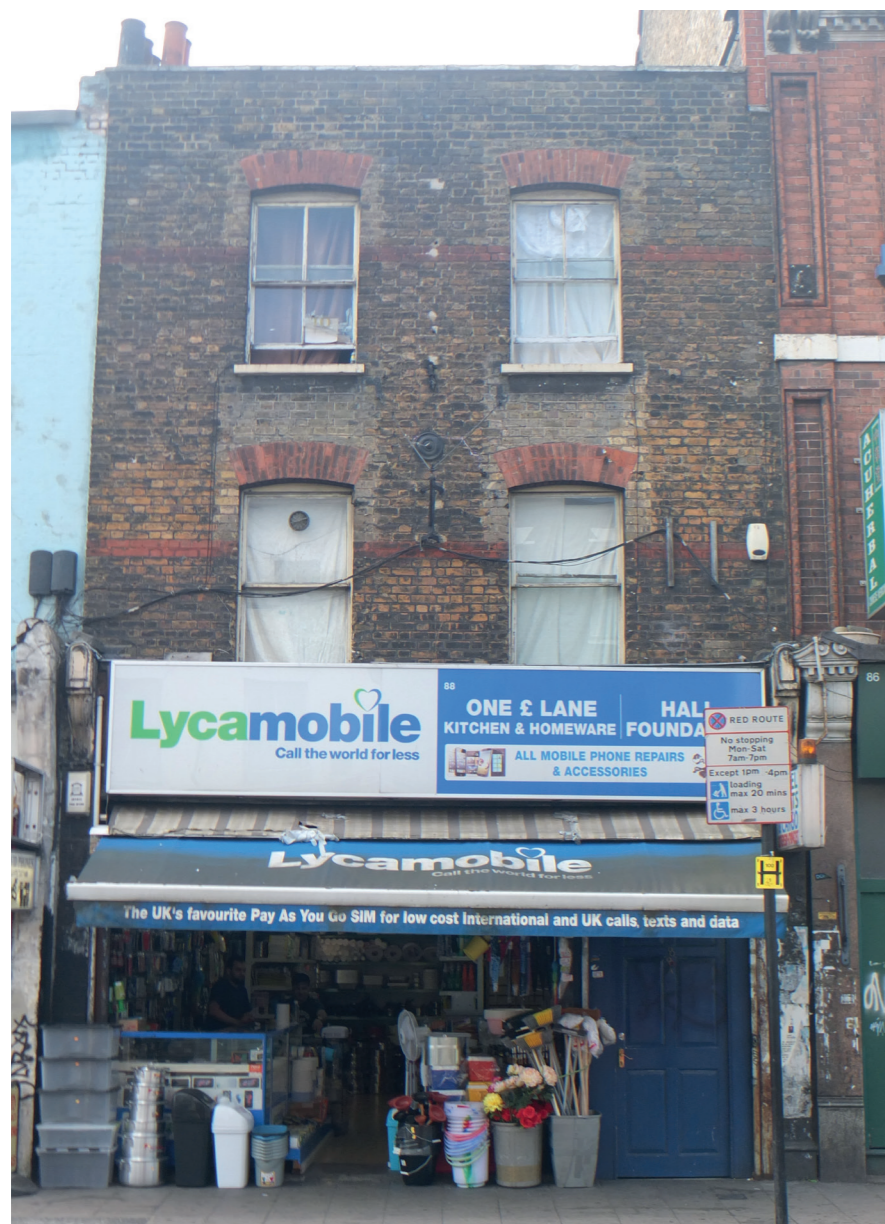
2018, before works

By 2018, many of the original features, and the timber windows, were in a poor condition. Structural repairs had previously been carried out following movement of the building. These repairs had disfigured the building, in particular damage caused by using cement mortar (which prevents the release of water-vapour and damages brickwork). After a brickwork survey, more repairs were carried out. Cement mortar was cut out and replaced with 'breathable' mortar made with a lime binder.

We installed a new shopfront, and undertook structural works. The existing pilaster heads were conserved, and a timber shopfront and cornice were reinstated with a Victorian awning to suit. An internal gridded shutter was installed to maintain a lively street presence.

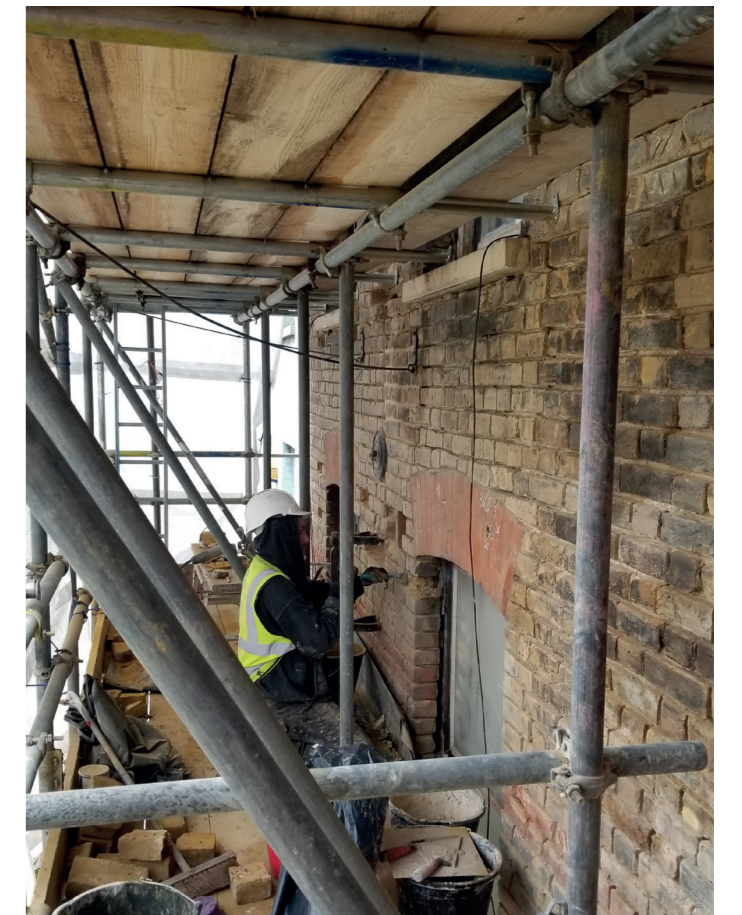
restoration works to the brickwork

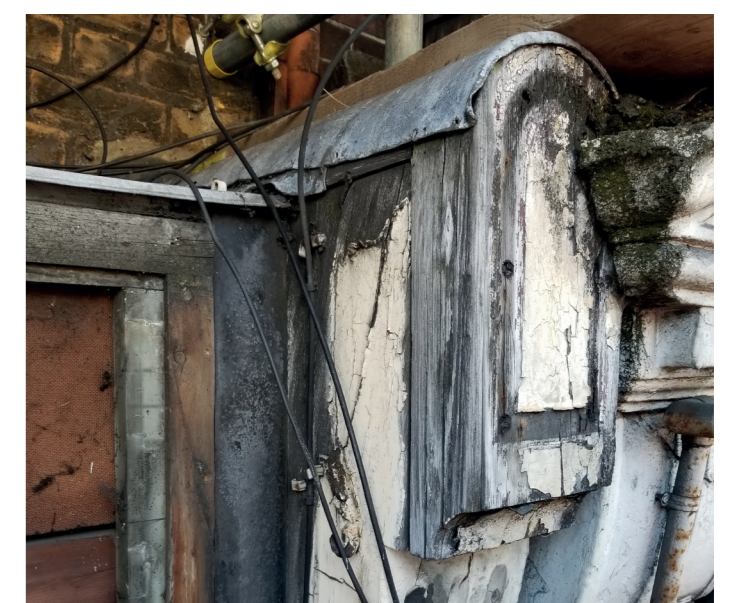
upclose view of the original pilaster head

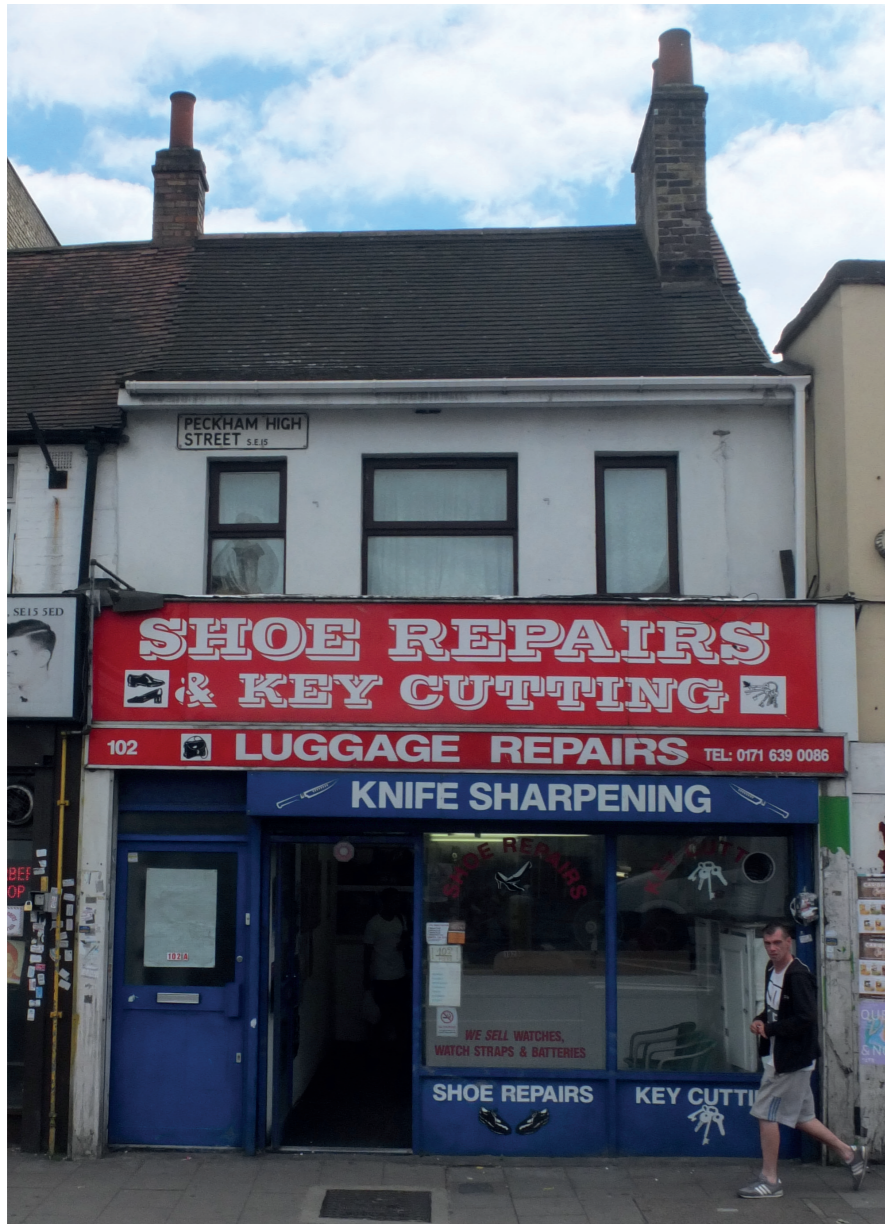
2019, before works

This building is a two-storey cottage which was built by 1830. It sits within the picturesque terrace made up of 98 – 104 Peckham High Street. This has survived from Peckham's past as a rural village. It is almost certain that the building was damaged by a WWII bomb blast, and a later shopfront was installed.

We lowered the eaves level, and reinstated the dormer window. The timber pilaster heads were restored, and the timber framed shopfront, including tiled stallriser was replaced. The new decorative ironwork above the shopfront is a close match of the original.

New windows were designed for the existing openings dating from the post-1945 version of the building, which is different from its original early 19th century form.

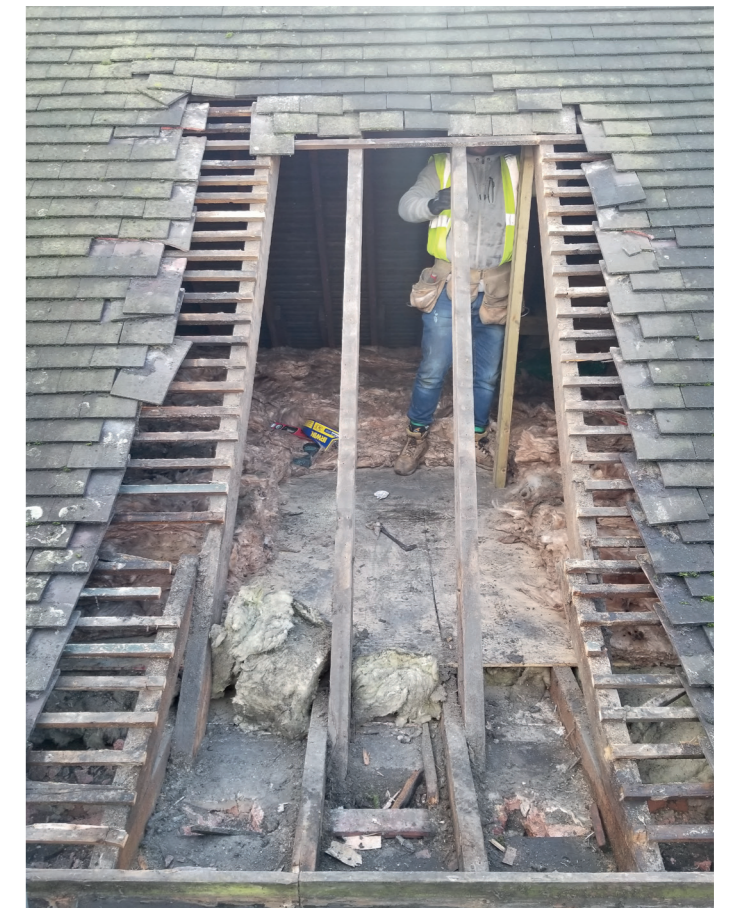
restoration works to the pitch roof dormer

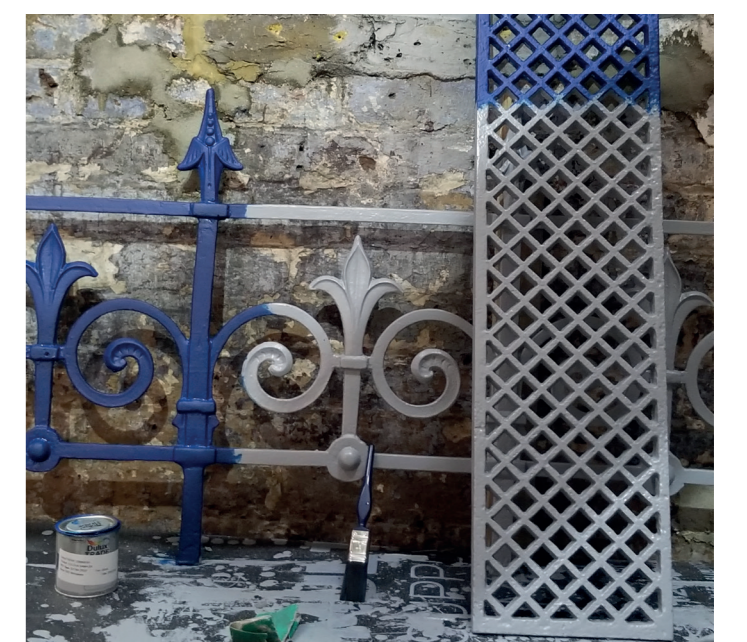
view of the new shopfront features

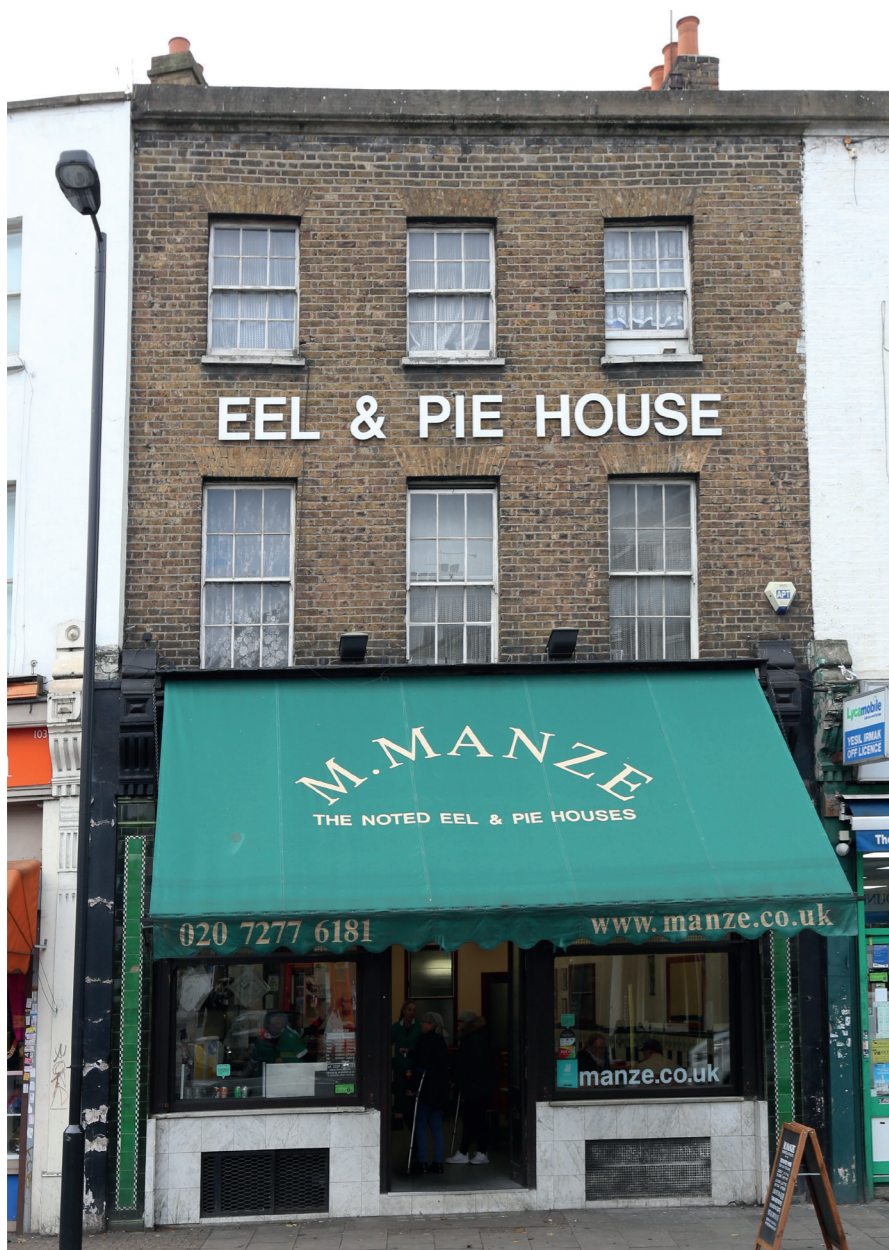
2019, before works

Manze's is a well-known Eel and Pie shop and part of the important early 19th century Shard's Terrace (91-107 Peckham High Street, and 126-130 Peckham Hill Street). While this handsome building was in a reasonably good condition, the pitched roof was in a poor state of repair and required a full replacement with traditional materials, including Welsh slate, and lead.

Several items required careful repair and decoration works. The new windows were painted green on the outside whilst being kept white on the inside. The stone parapet was painted to match the brickwork signage. The shopfront pilaster heads and shopfront itself were carefully sanded down, repaired, and repainted.

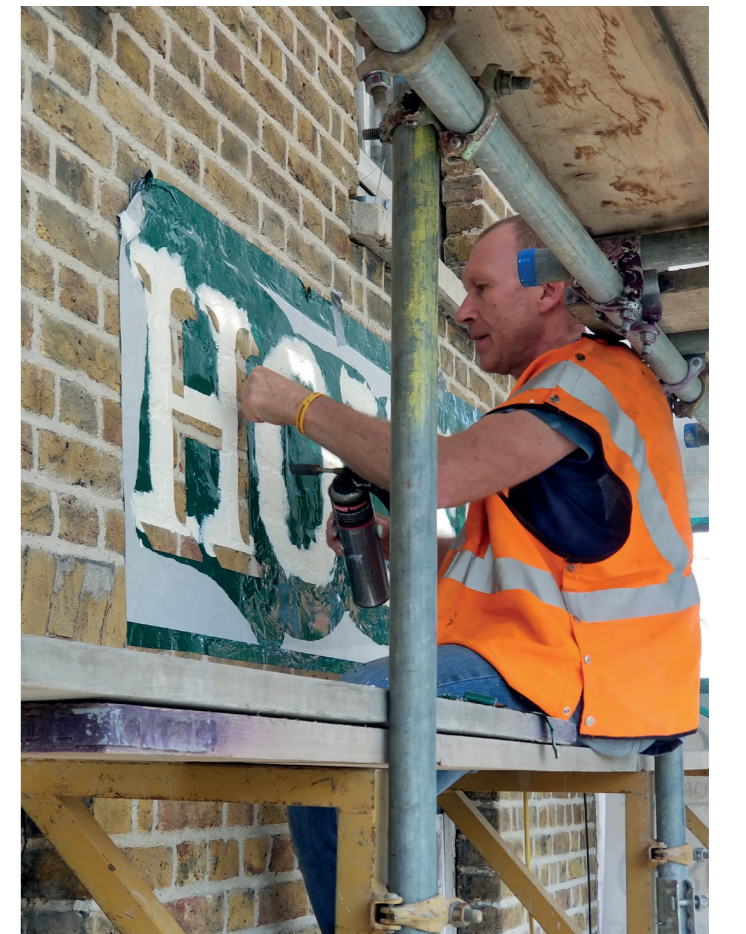
new signage using handpainted stencil graphics directly onto the brickwork

Refreshing the iconic *Eel & Pie House* signage on the brickwork was a priority piece of work, as the previous signage was in a poor state and wasn't sympathetic to the host building. After testing several ideas, a simple, effective drop shadow design was agreed and carefully hand painted using stencils to bring it to life and complement the historic nature of the building.

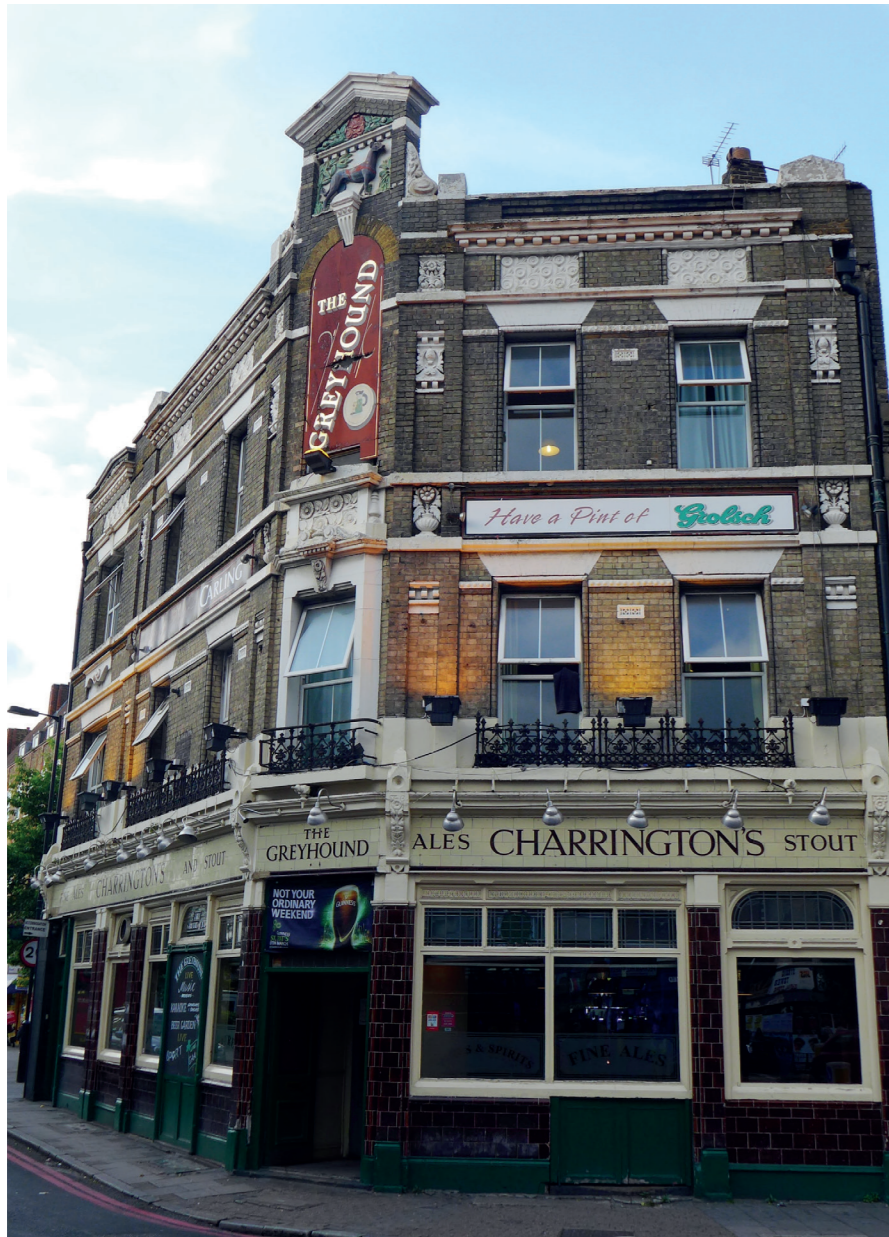
2018, before works

Due to unsuitable previous repair works, the existing tile work at lower level in the pilaster face had fractured. Repair required stripping back the tiles, restructuring the backing and facing with matching tiles. At lower level, all the old paint was removed, exposing the tile work. These areas proved to be in worse condition than anticipated, especially the tiled frieze and pilaster bases. Due to this area being heavily used, missing moulded features were rebuilt in cement and the skirting was redecorated, resulting in the new skirting closely matching but being more robust and more easy to maintain.

Following the success of the stained-glass restoration work at The Old Crown (119 Peckham High Street) the same subcontractor undertook the repair of the striking stained glass fan lights above the ground floor windows.

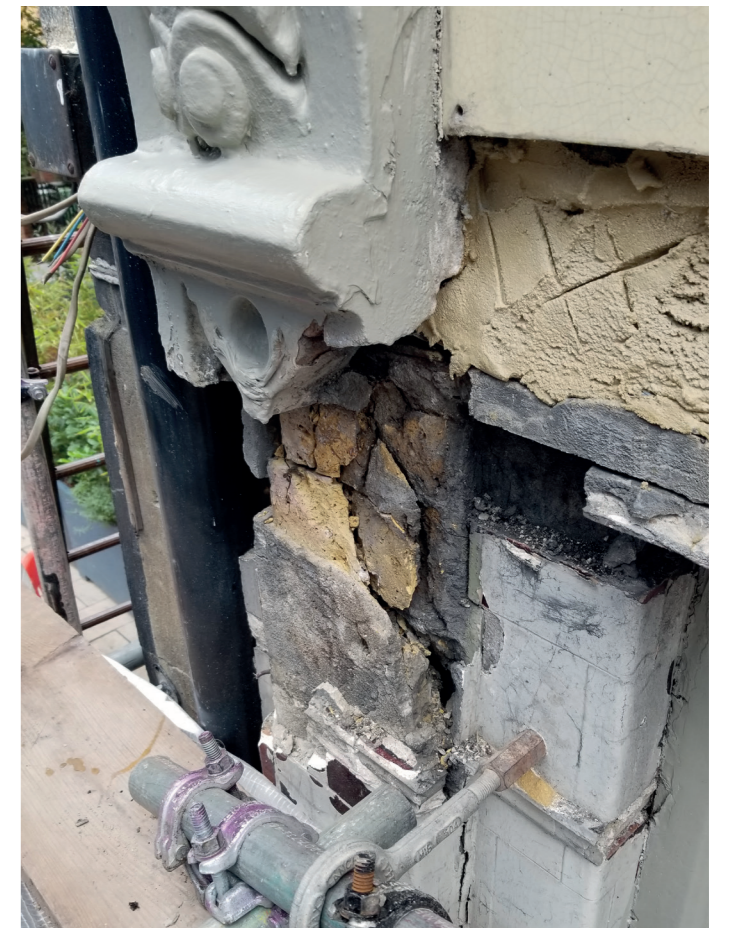
investigation works to a missing pilaster head

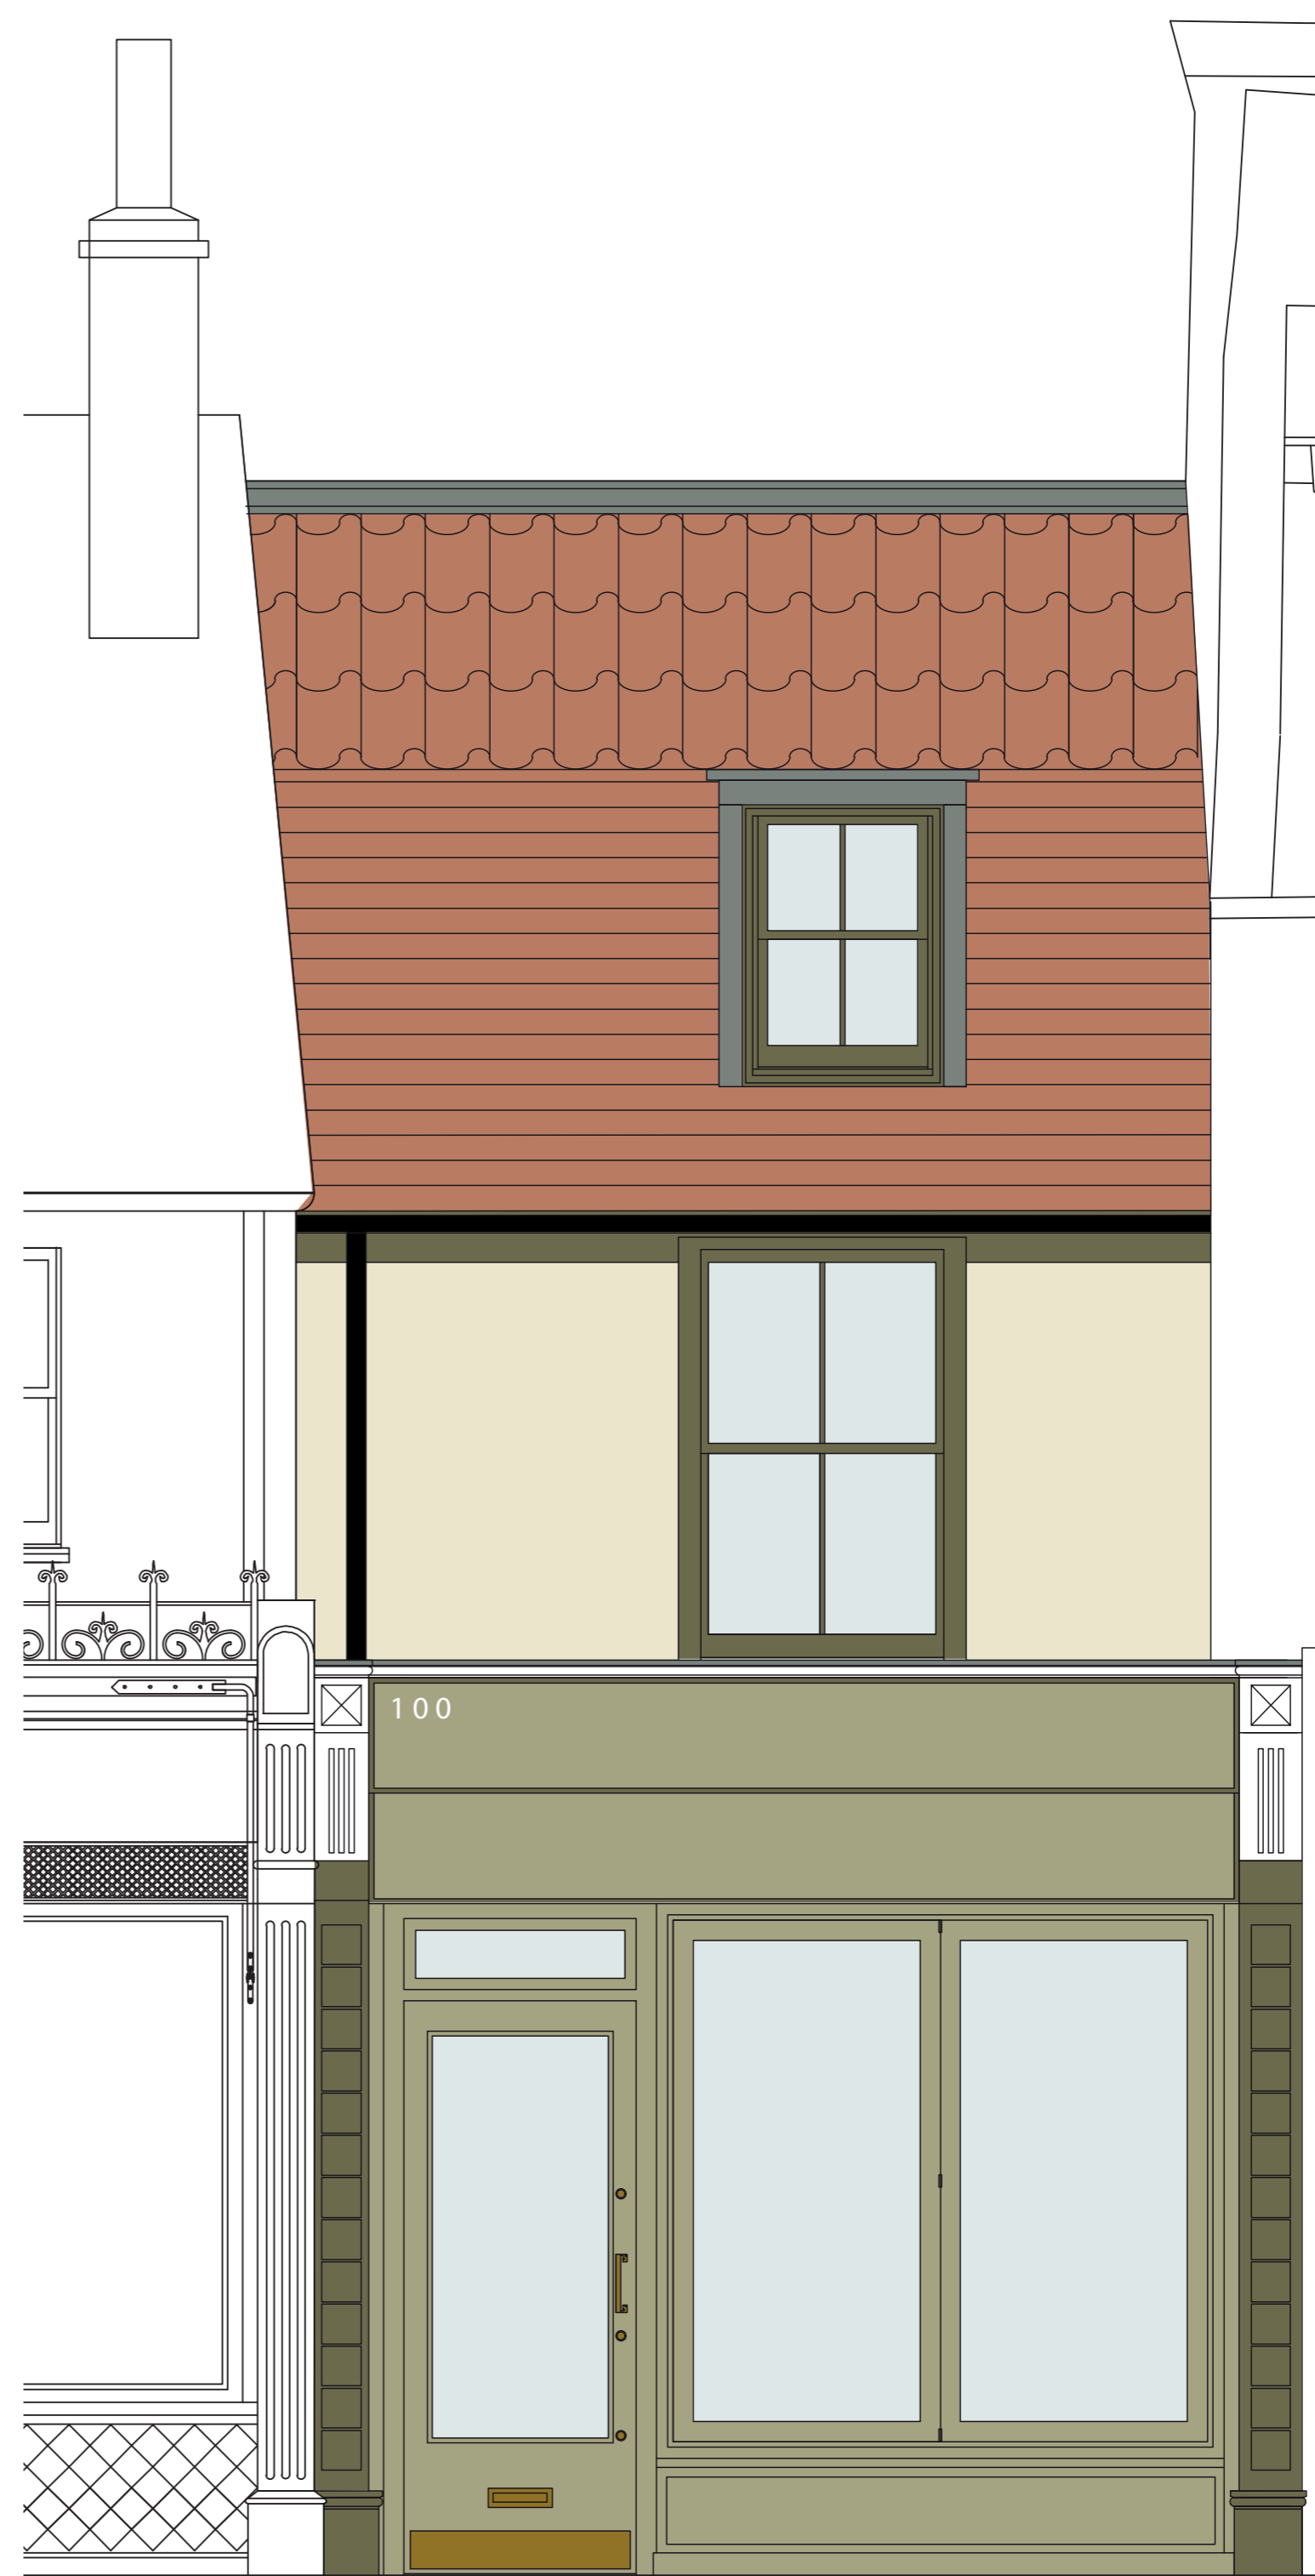
This is the final building to be completed in the THI scheme. The ungainly first floor extension, built in the 1950s, will be removed, the first floor and roof will align with neighbouring buildings, and a new frontage is proposed. To the rear, the former British School (Boys) building, dating from 1871, will be repaired and retained. The work to this building will support the conservation of the picturesque terrace made up of 98 – 104 Peckham High Street, which will transform the historic townscape character of this section of Peckham town centre.

Proposed new street frontage to 100 Peckham High Street
