Southwark Council

Ledbury Estate

Structural Robustness Assessment
for Large Panel System Tower
Blocks with Piped Gas

Issue 2 | 30 August 2017

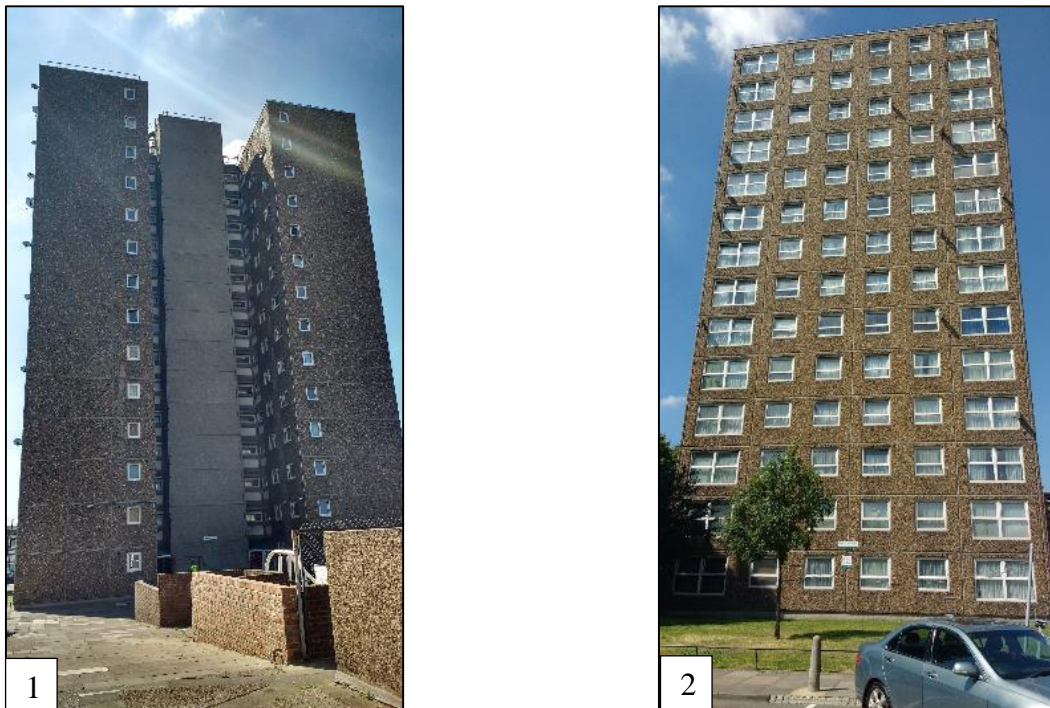
Figure 1 Peterchurch House on Ledbury Estate

There are four geometrically identical tower blocks on the Ledbury Estate; Bromyard House, Peterchurch House, Sarnsfield House and Skenfrith House, each are 14 storeys high, with a floor to floor height of approximately 3m (Figure 1). Each has a 'H-shaped' floorplan, with two sets of flats on each floor separated by a lift and stair core at the centre, see Figure 2.

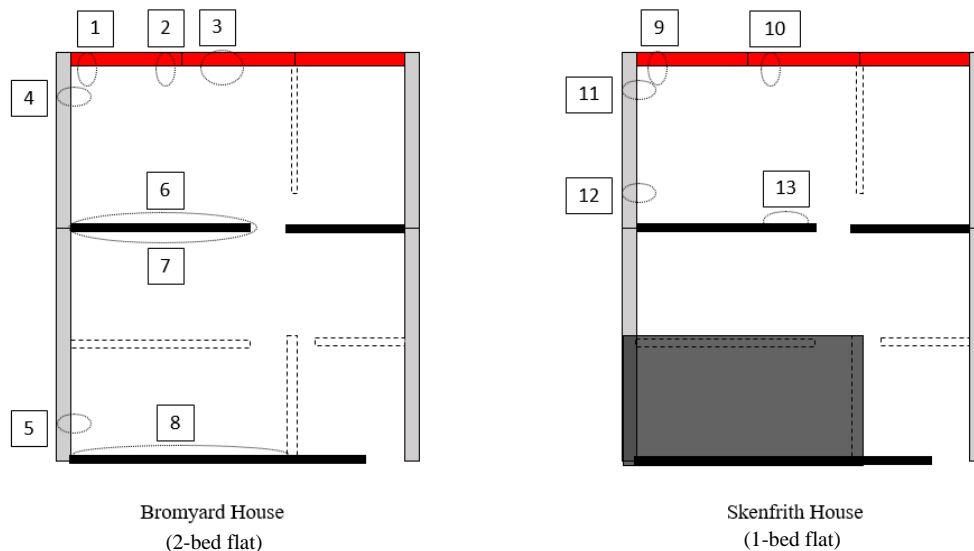
Figure 4 Floorplans of the two flats showing the locations of the intrusive investigation works

The locations of the investigation works undertaken are shown in Figure 4. While the two flats have the same general layout, the flat in Bromyard House has two bedrooms, while the flat in Skenfrith has one bedroom (the room shaded grey in the sketch below is the third bedroom to the neighbouring flat). This sketch is referred to throughout the following Section.

Interlocking reinforcement between the top of the flank wall panels and the floor slabs was found; located at 300mm centres. A sketch of this detail (based on the investigation findings) can be seen in Figure 7. Three fixings were exposed; two at location 3 and one at location 10 (seen in Figure 4).

The location of each vertical joint was initially located using the non-destructive scanning tools and four locations were subsequently intrusively investigated; locations 1, 2, 3 and 9, as seen in Figure 4. At location 1, the base of the joint was exposed and two steel bars were observed, this is assumed to be the lapping of the vertical bars, one bar ends just below the bottom of the sheath and one bar extends into the in-situ joint. At location 2, the sheath and bar were exposed at mid-height – a single bar was found. At location 3, both the base and top of the joint was exposed. In both instances a single bar extending into the in-situ joint was observed. The bar and sheath was also exposed at mid-height at this location; again revealing a single bar. At location 9 the base of the joint was exposed and a lapped detail similar to that at location 1 was observed.

Removing the skirting boards along the base of the load-bearing cross-walls in Bromyard House revealed 10mm thick, steel L-brackets (see Figure 12) bolted to floor slabs and walls at locations 6, 7 and 8 (Figure 4). Four brackets are spaced along a length of ~5m at location 8 (Figure 12), while three brackets are spaced along a length of ~4m at locations 6 and 7. No L-brackets exist at ceiling (soffit) level. No further investigations were undertaken on these cross-walls.

No L-brackets are present along the cross-walls in Skenfrith House. However, interlocking reinforcement at 300mm centres tying the top of the cross-wall panels to the floor slabs (similar to the flank wall fixing described in Section 3.2.4.1) was found at location 13 (Figure 4). The extent to which the joint was exposed can be seen in Figure 13. The joint was only exposed from one side, the dotted outline of Figure 13 was not investigated.

Only one joint was exposed, at location 13 (Figure 4), two 8mm plain vertical bars extending down into the in-situ concrete joint were found. It is unknown if the two bars extend the full height of the joint or if the bars are lapped.

The non-structural wall panels are stacked upon each other and were not originally designed to carry vertical load, other than self-weight. They are tied back to the floor slabs with two ties per panel. Electromagnetic scans were used to locate the fixing details and two fixings (at locations 4 and 5 - Figure 4) were exposed. Different details were found at each locations (Figure 16), however the general principle is the same; the ties loop around a bolt (connecting adjacent non-structural wall panels) and are restrained via bolts to the top of the slab. The floor screed was broken away to reveal the ties from the inside and concrete was also broken away to reveal the bolt from the outside (Figure 15).
