**Ledbury Estate**

Structural Assessment of Bromyard,  
Peterchurch, Sarnsfield and Skenfrith  
House

Issue | 20 November 2017

Job number 245112-05

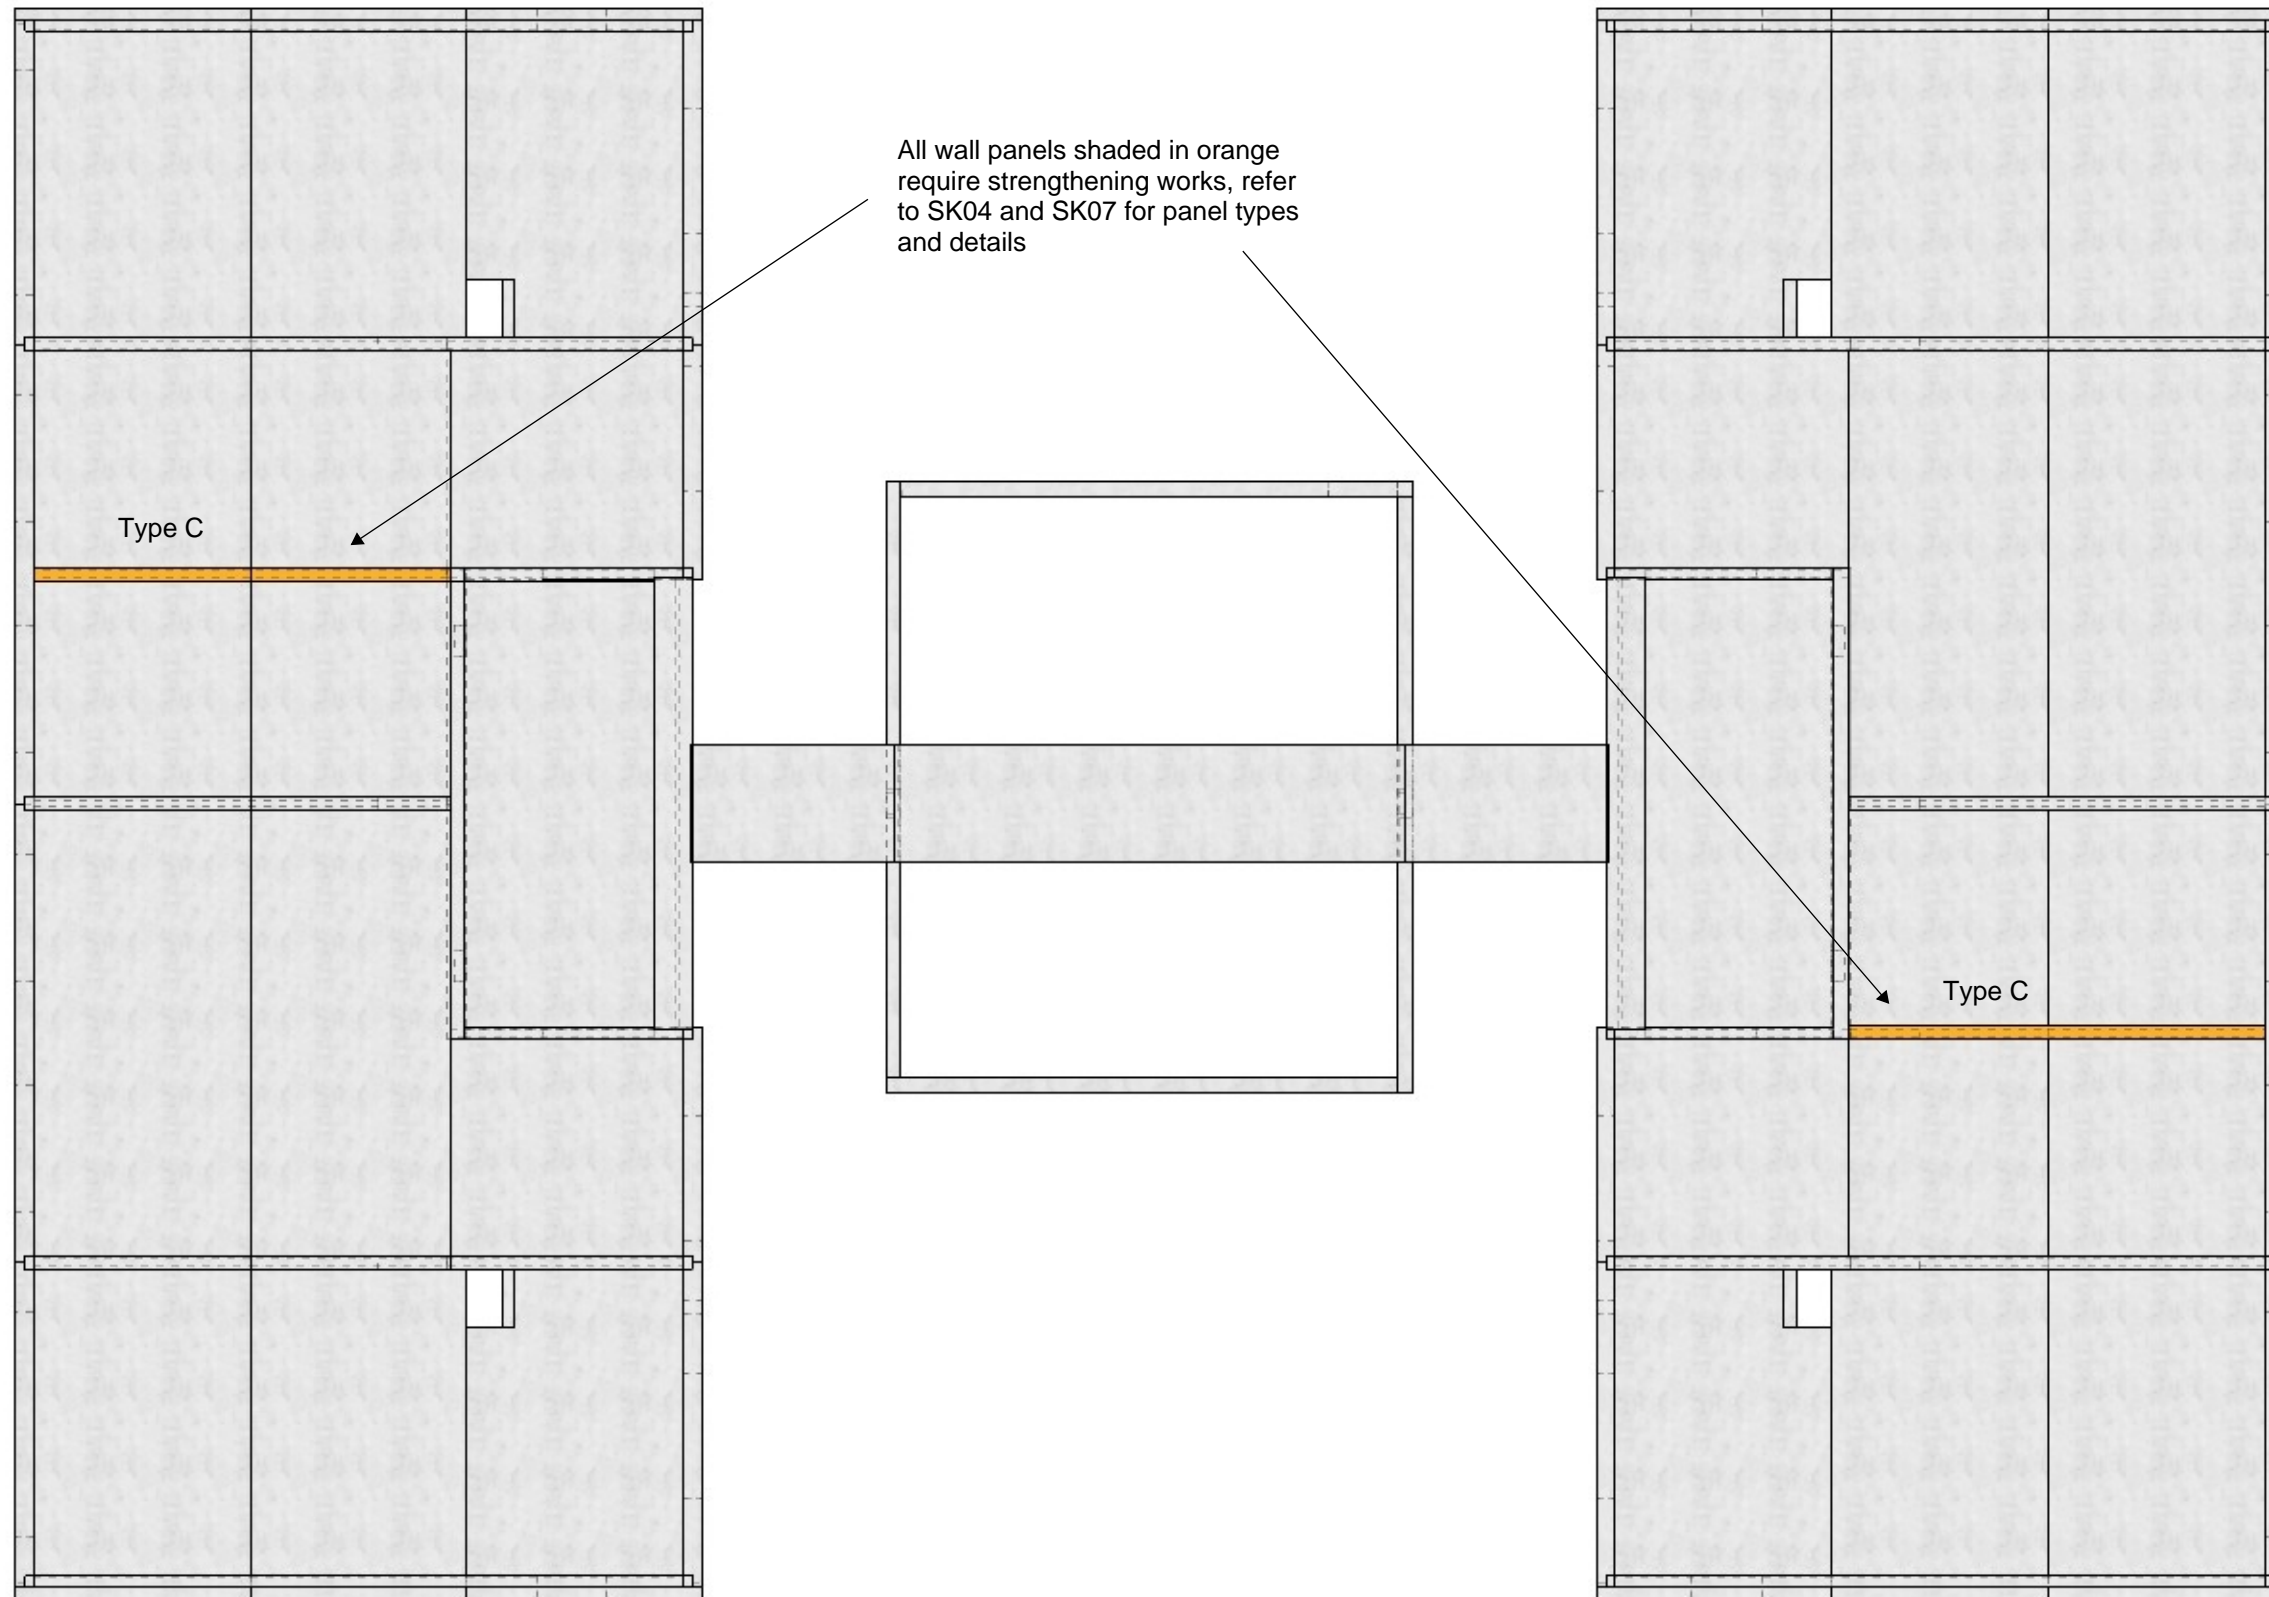
All wall panels shaded in orange require strengthening works, refer to SK04 and SK07 for panel types and details

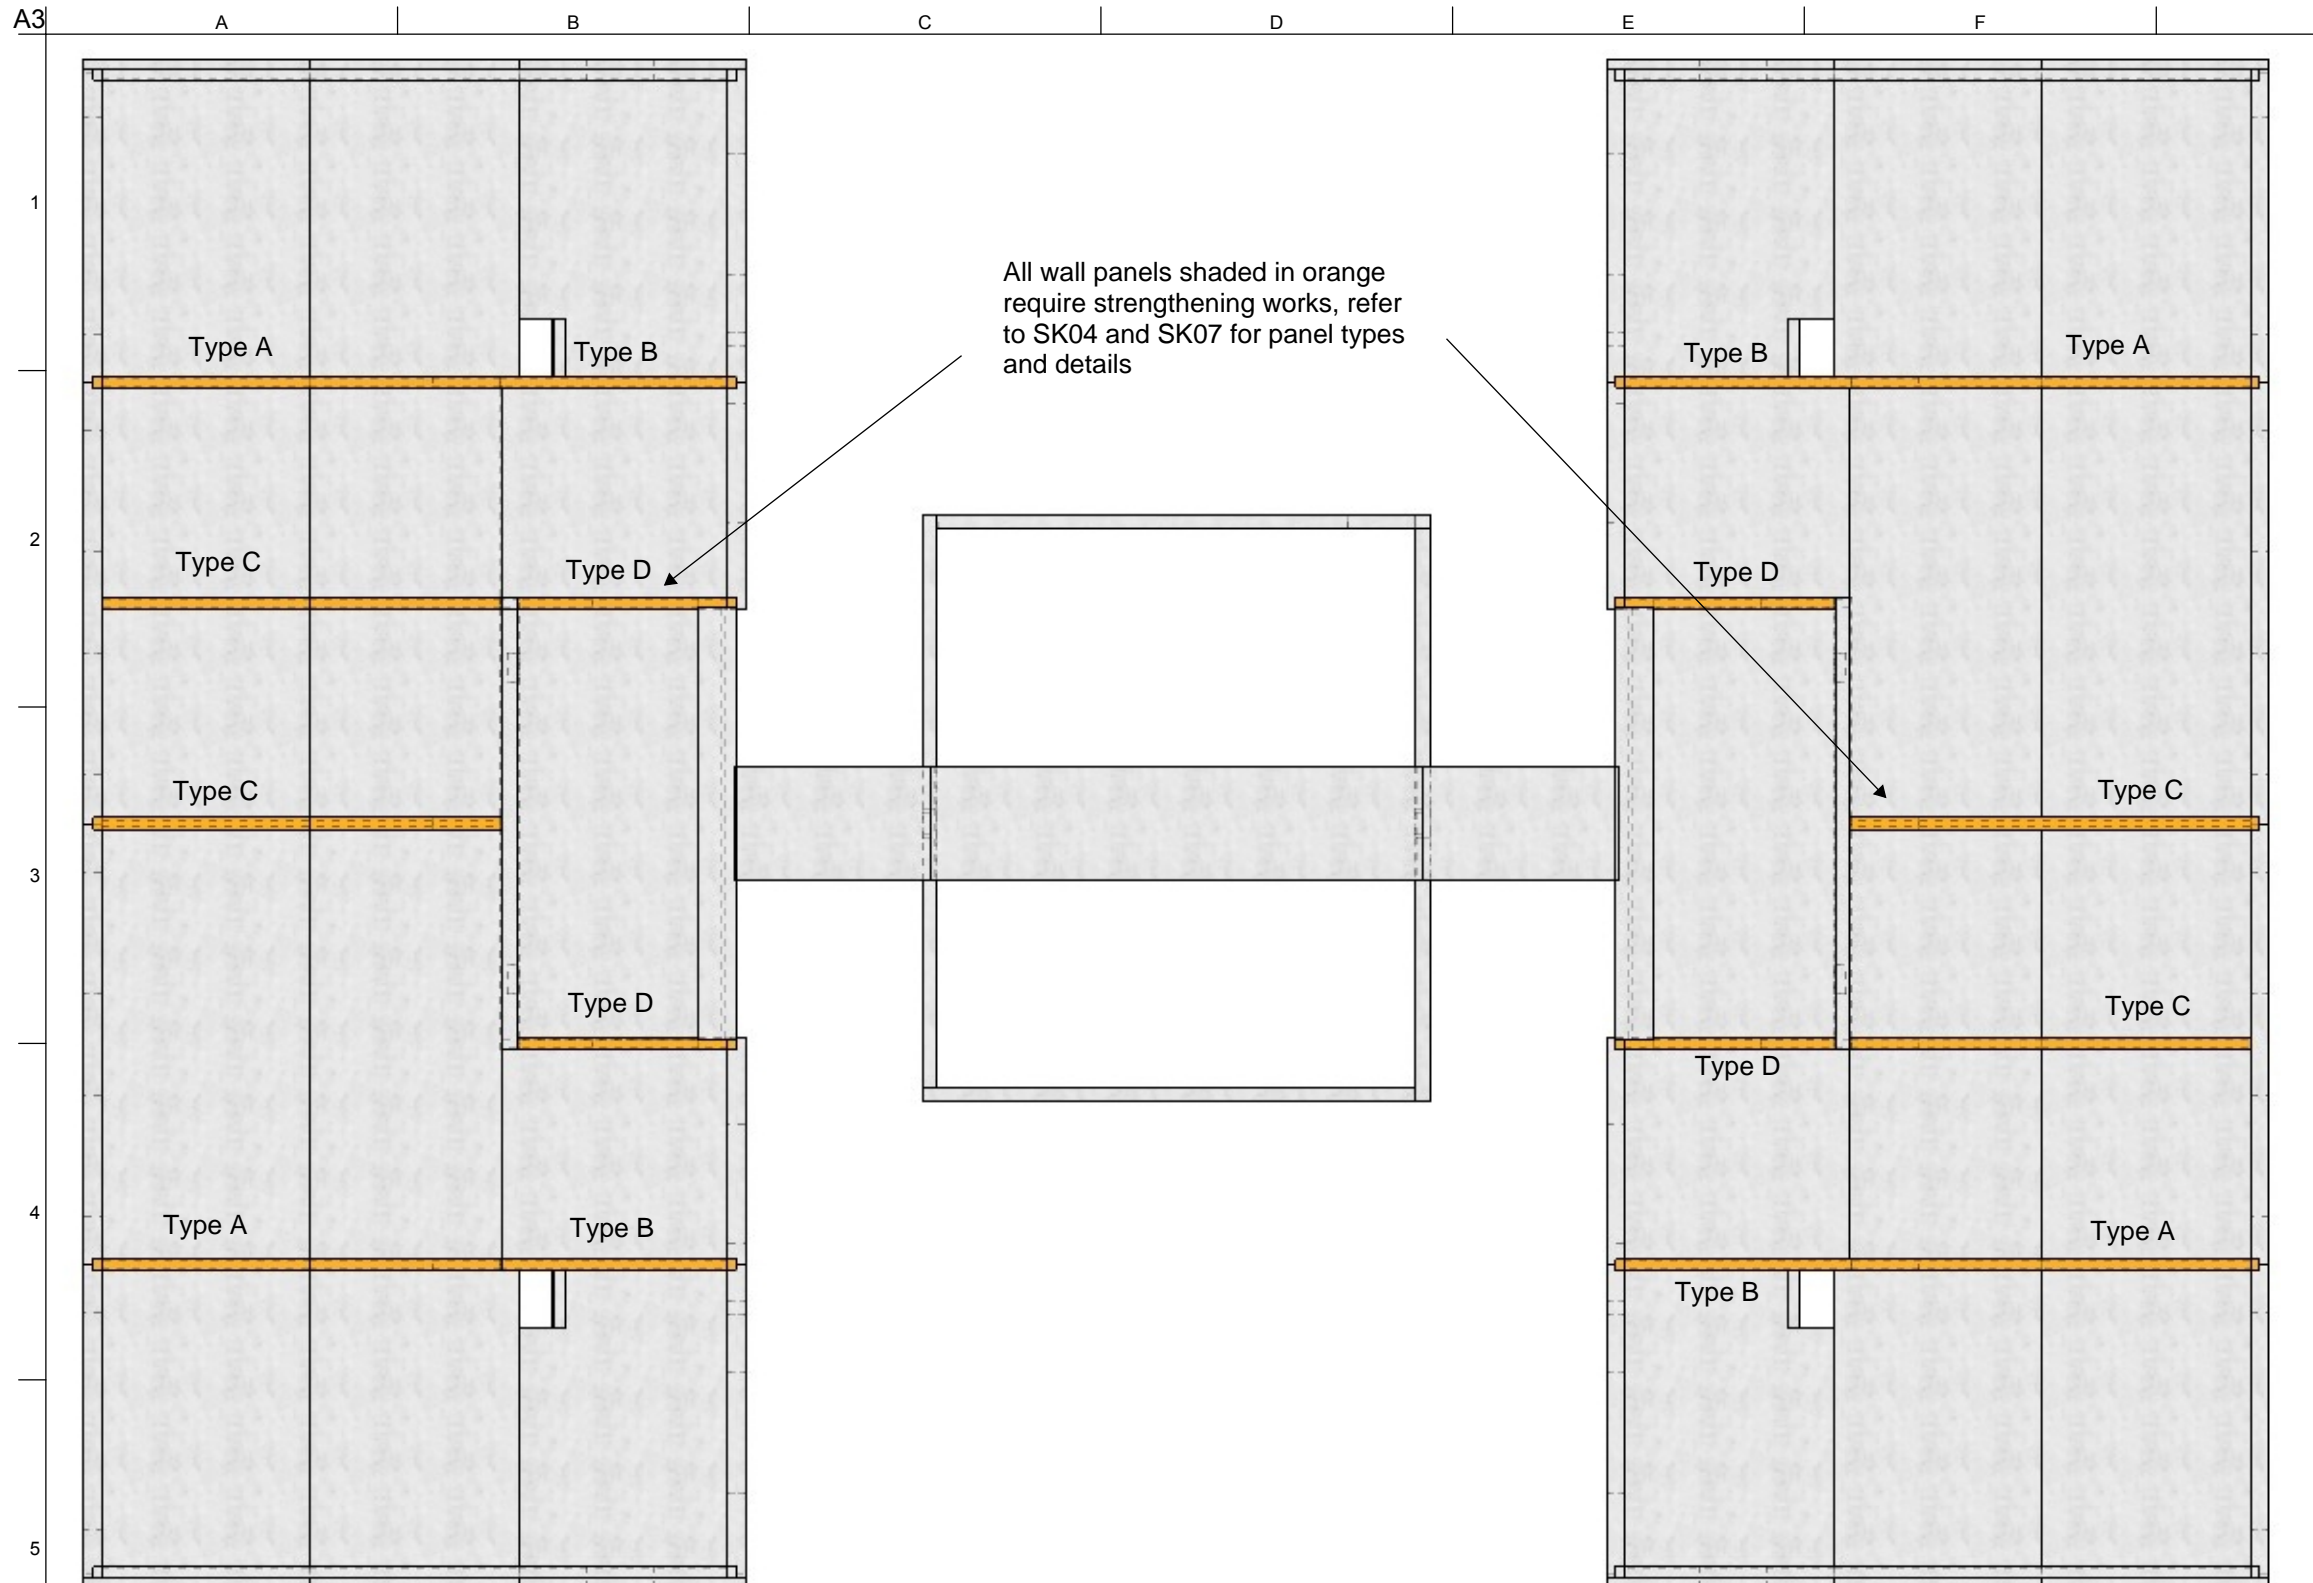
Cross wall panel strengthening layout  
 Skenfrith House - level 8 to roof - 6 storeys  
 Peterchurch House - level 8 to roof - 6 storeys

All wall panels shaded in orange require strengthening works, refer to SK04 and SK07 for panel types and details
