**Subject** Summary of Structural Assessment of Bromyard, Peterchurch, Sarnsfield and Skenfrith House  
**Date** 21 November 2017 **Job No/Ref** 245112-05

This document provides a summary of the Arup report called “Ledbury Estate: Structural Assessment of Bromyard, Peterchurch, Sarnsfield and Skenfrith House” dated 20 November 2017.

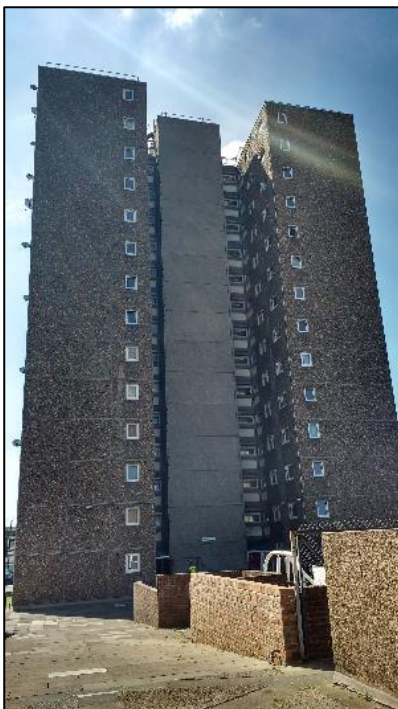
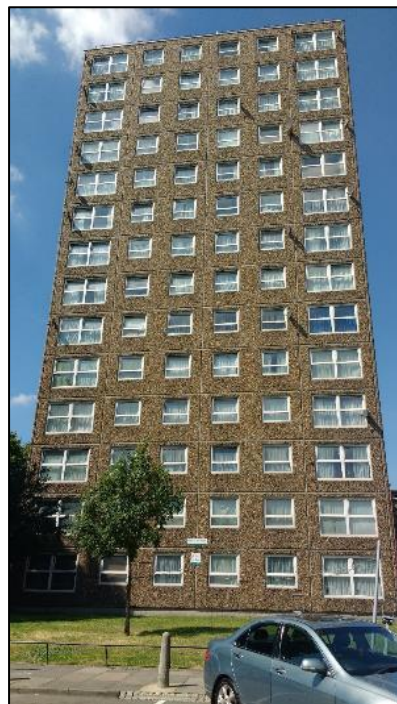
Figure 1 Peterchurch House

All of the blocks are 14 storeys high and ‘H-shaped’. In every block there are four flats per floor; two flats on both sides of the stairwell and lifts in the middle.

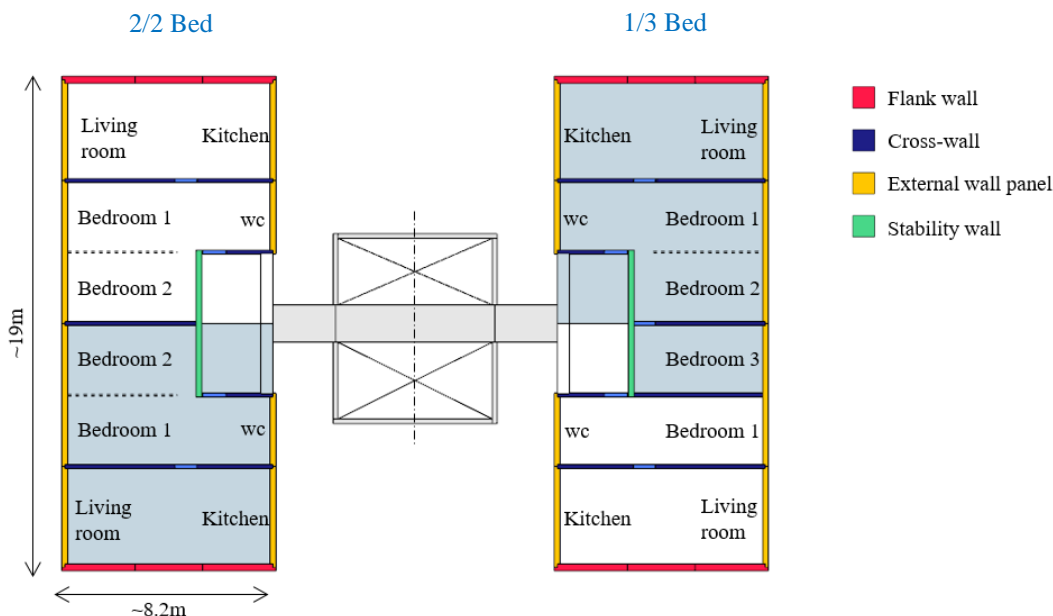
In the flats, there are three main types of wall panels. The “flank” walls and internal “cross” walls support the floor slab panels. The other external walls don’t need to support the floor slab panels because these are already being supported by the cross walls and the flank walls.

The areas containing the lift and stairs in the middle of the buildings are also built from concrete panels.

Figure 2 Approximate floorplan of the Ledbury Estate tower blocks. For illustrative purposes a one and three bedroom flat layout is shown on the same floor as a two-bedroom. Some partition walls have been omitted for clarity.

Each floor panel is supported by two walls, one at each end of the floor panel.
